United General District 304 Facility Tree Risk Assessment

ISA Level 2 Basic Tree Risk Assessment and Risk Mitigation Plan

September 16, 2024

**United General District 304 Facility
Sedro-Woolley, Washington**

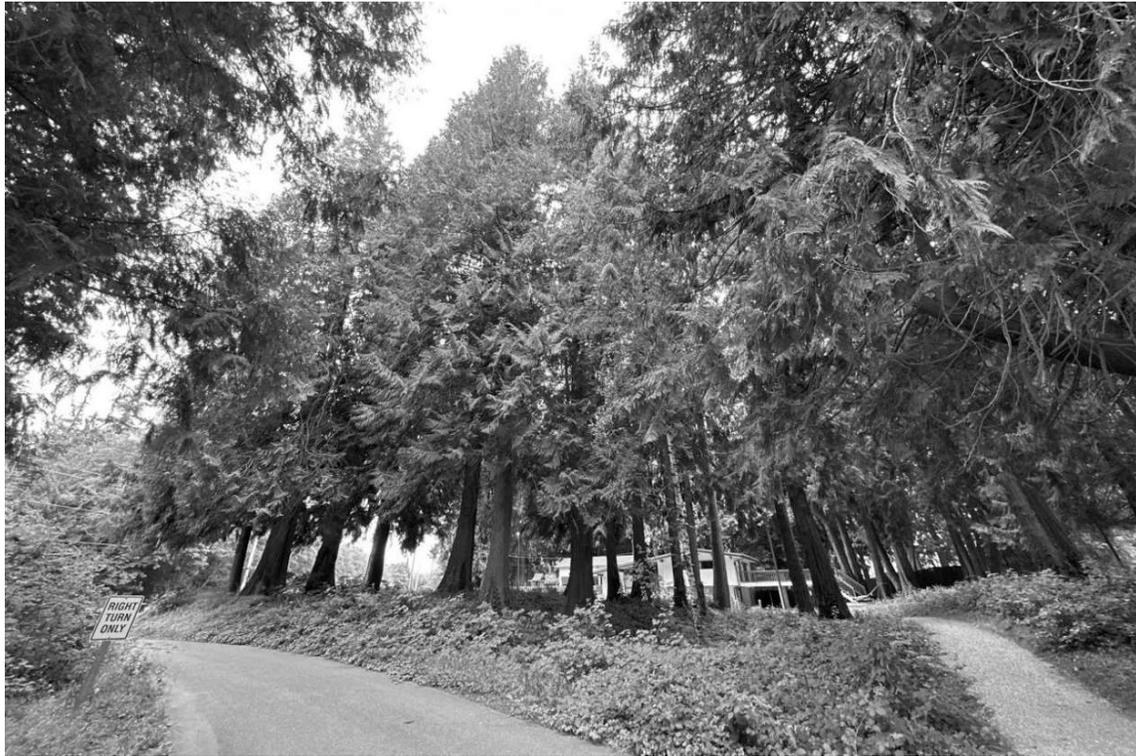
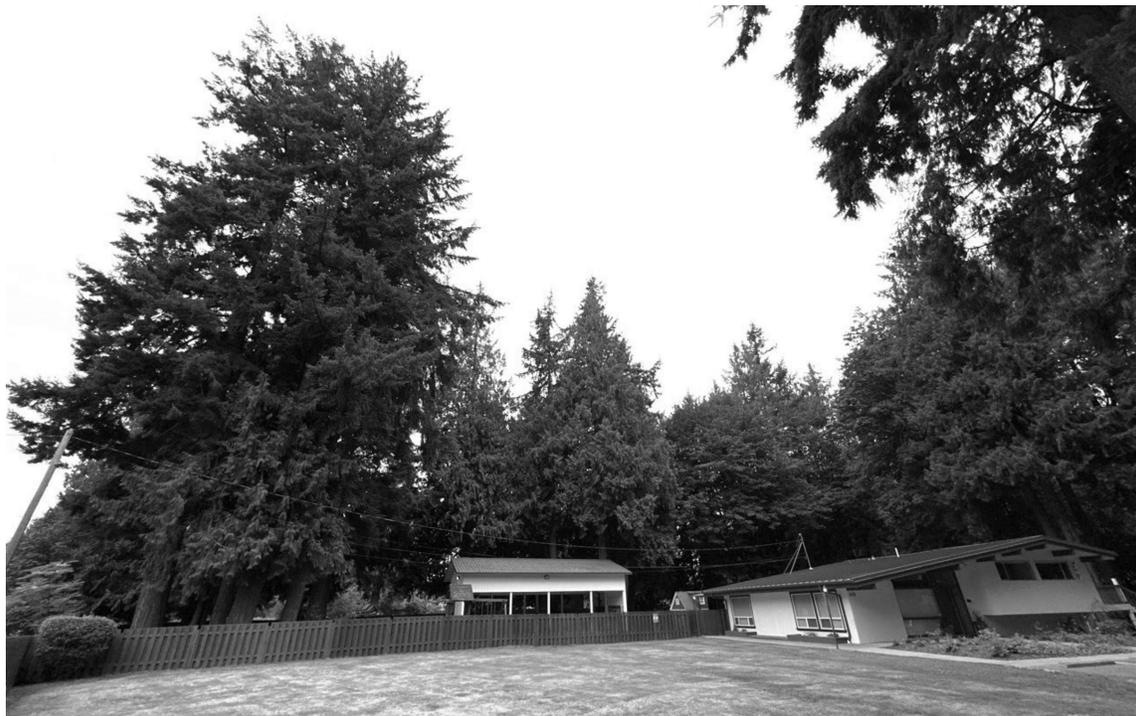
Photos 1 & 2. These photos show significant portions of the site and assessment area as well as important targets considered during my assessment. Photo 1, upper frame, looking west, shows the exit road and gravel pedestrian path. The Heartwood House can be seen behind the trees. Photo 2, lower frame, looking northwest, shows the Heartwood House and the fenced recreational area to the facility's rear.

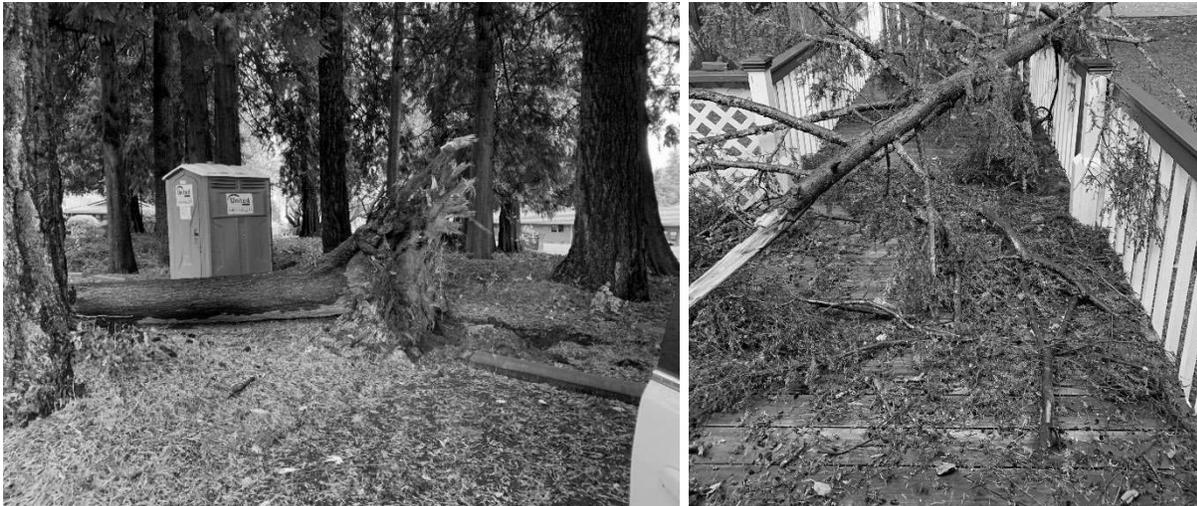
In reviewing photos of the failed tree provided by UGD 304, it appears that the tree was a mature western hemlock (*Tsuga heterophylla*). Because only photos were available to me preceding my fieldwork, and I was not able to evaluate the failed tree in person due to the timing of the event and our engagement, I am unable to provide a conclusive assessment of the failed tree and what may have caused its failure. Still, based on the photos provided, the tree's crown appeared to be somewhat diminished and thin, and the failed roots in areas of the failed root plate appeared stunted and limited in their spread. What I observed in the photos appeared similar to common symptoms of root disease. In the photos, it also appears as though there may have been little to no root flare on the northwest side of the tree, indicating root growth may have been limited in this area, damaged at some point, or there could have been a girdling root in that location.

Photos 3 & 4. These photos show parts of the failed root plate (L) and canopy (R) of the tree that failed in 2023.

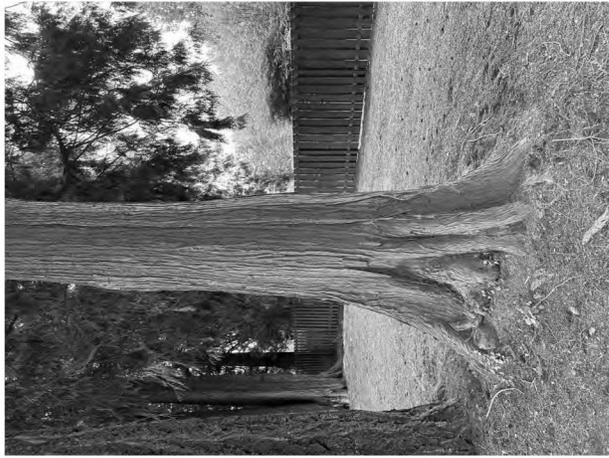
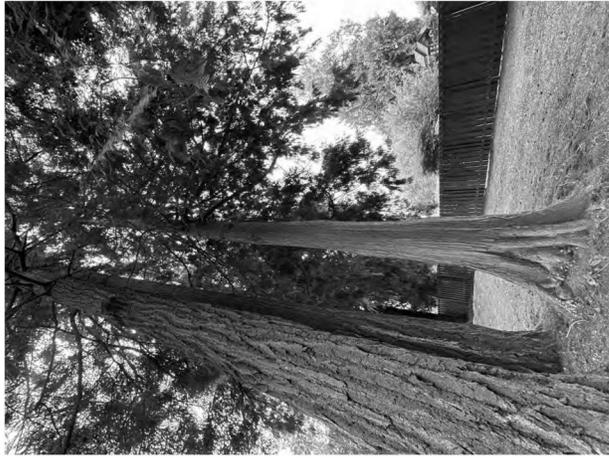
Notes: This tree contains a small codominant stem in the upper canopy. The codominant stem appears inconsequential and relatively well attached at the union. This tree exhibits a slight phototropic lean to the northwest due to its close proximity to neighboring trees. The base of the trunk has some swelling at around 5 feet. Sounding of the swollen area sounds relatively solid.

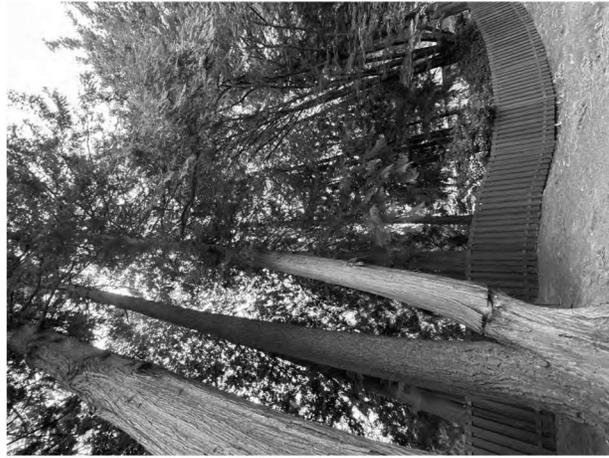
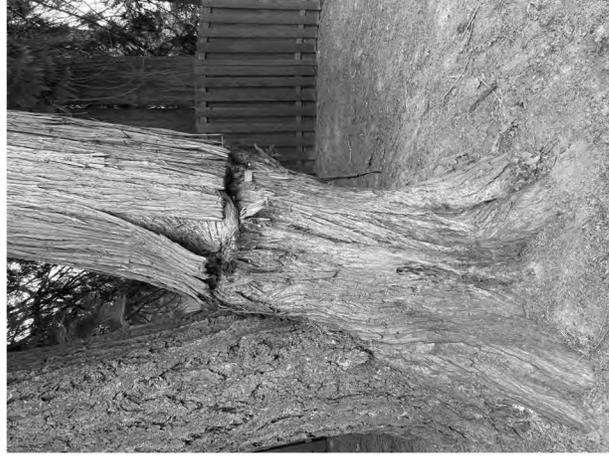
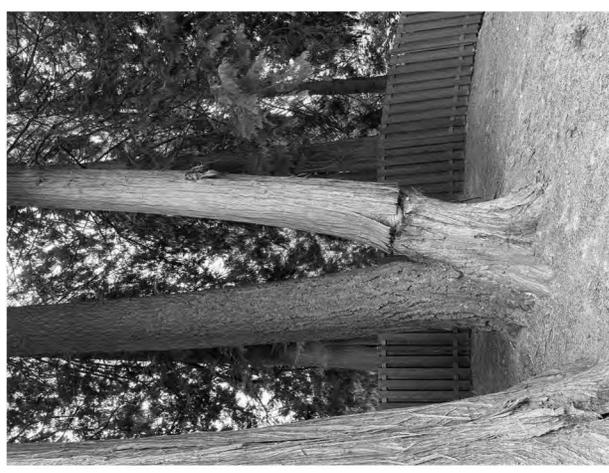
Notes: This tree leans significantly to the south. The tree has self-corrected over time. There appear to be numerous stress cracks on the stem from the significant lean. I observed what appeared to be brittle cinder fungus on the north side at the base. There is a large failed branch hanging in the upper canopy that could be prone to dislodging.

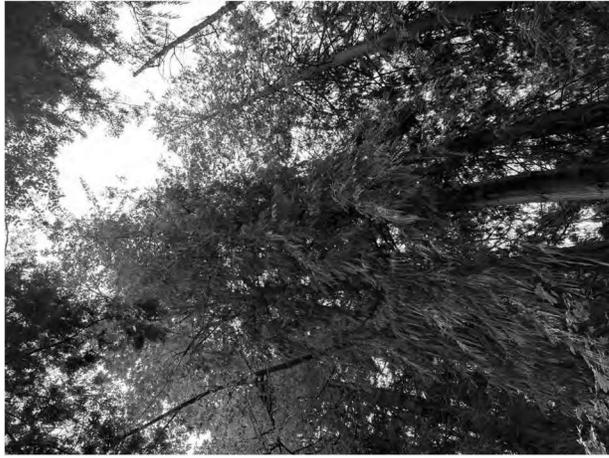
Notes: This is a very large cedar. It appears this tree may have grown from a nurse stump. This tree has a significant lean to the north. The tree has self-corrected significantly over time, creating a significant bow in the trunk. Most of the live branching is on the south side of the tree. The base of the tree contains various areas of decay and hollows. Significant reaction growth has occurred around these hollow areas at the base; it appears this tree has adapted to these defects over time.

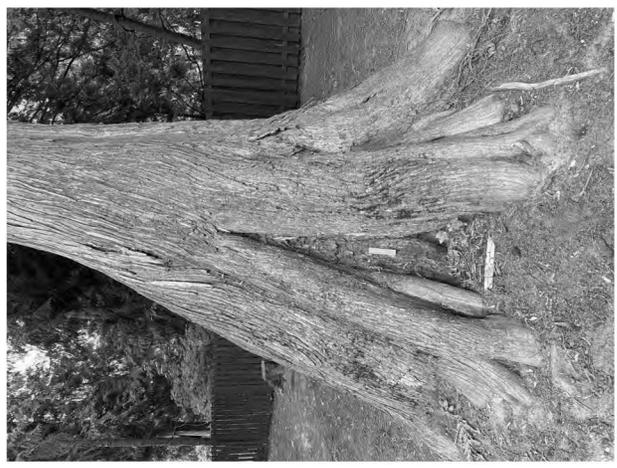
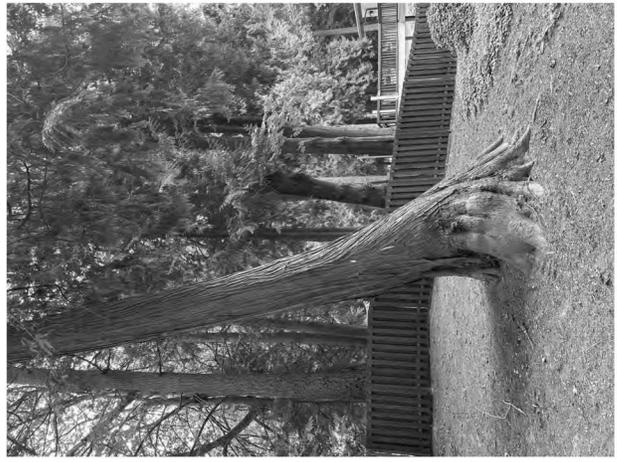
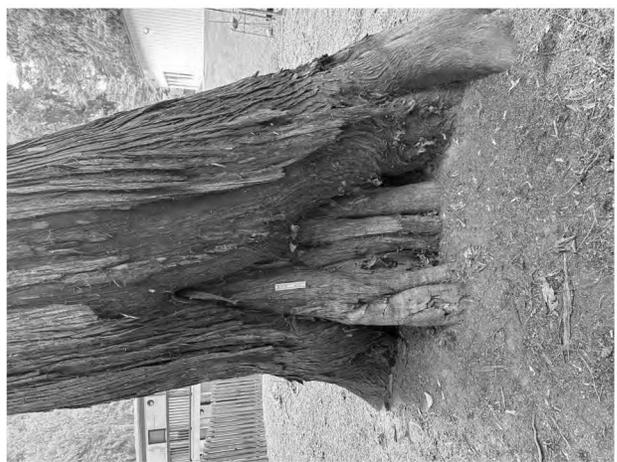
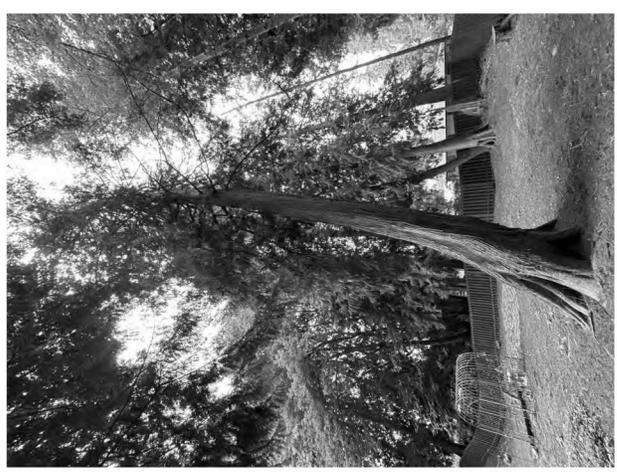
Notes: This tree leans significantly to the northeast. The primary fall direction would be into the parking spaces below. A neighboring stem that adjoins the lower trunk has been removed.

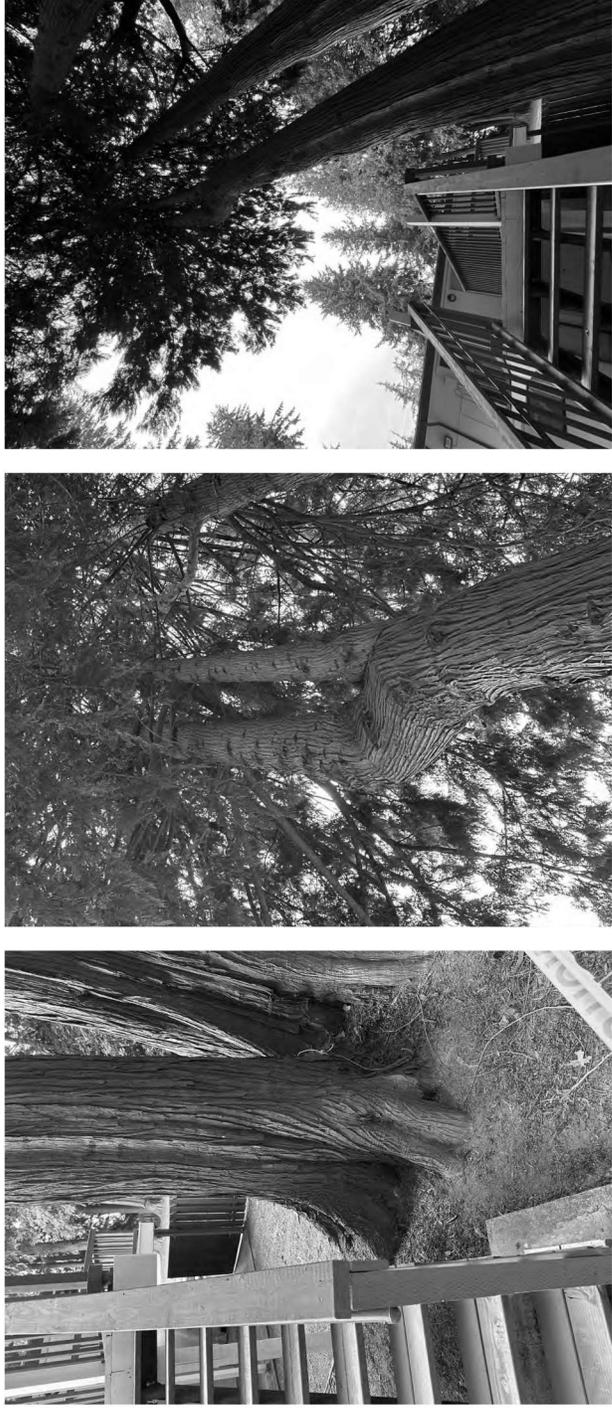
Tree ID: **41**

Notes: This large cedar appears to have lost its top at one time. The tree sounds hollow when struck with a mallet at the base. The tree is relatively well protected in the center of the grove and appears to be relatively stable. The tree should be monitored to ensure the tree does not degrade to an unacceptable point.

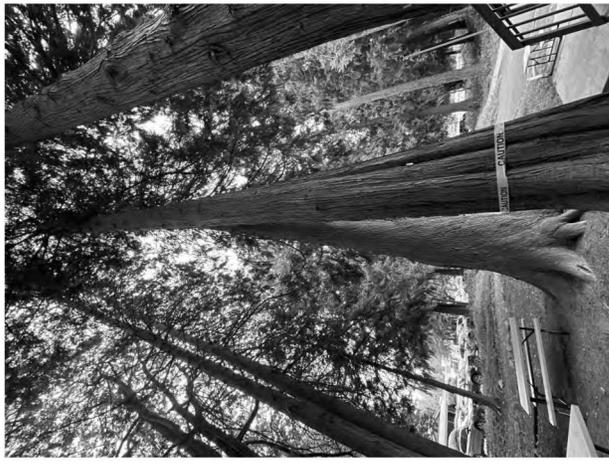
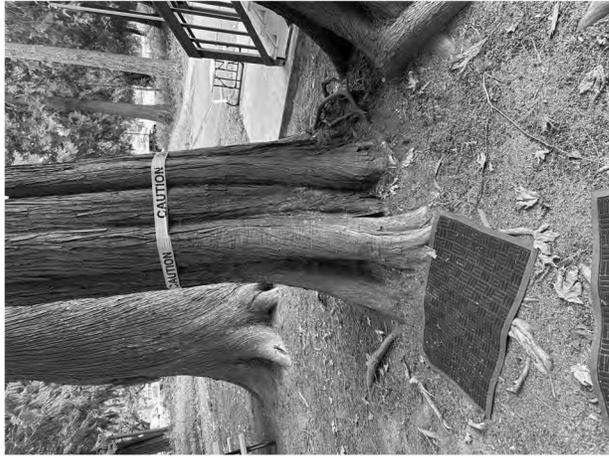
Tree ID: **42**

Notes: This large cedar exhibits slightly diminished vigor in the upper canopy. The lower portion of the stem, up to roughly 12 feet, bulges and appears to be swollen, which is likely indicative of internal decay or adaptive stress from wind loading. The tree leans slightly to the east and bows upwards in a self-corrective manner.

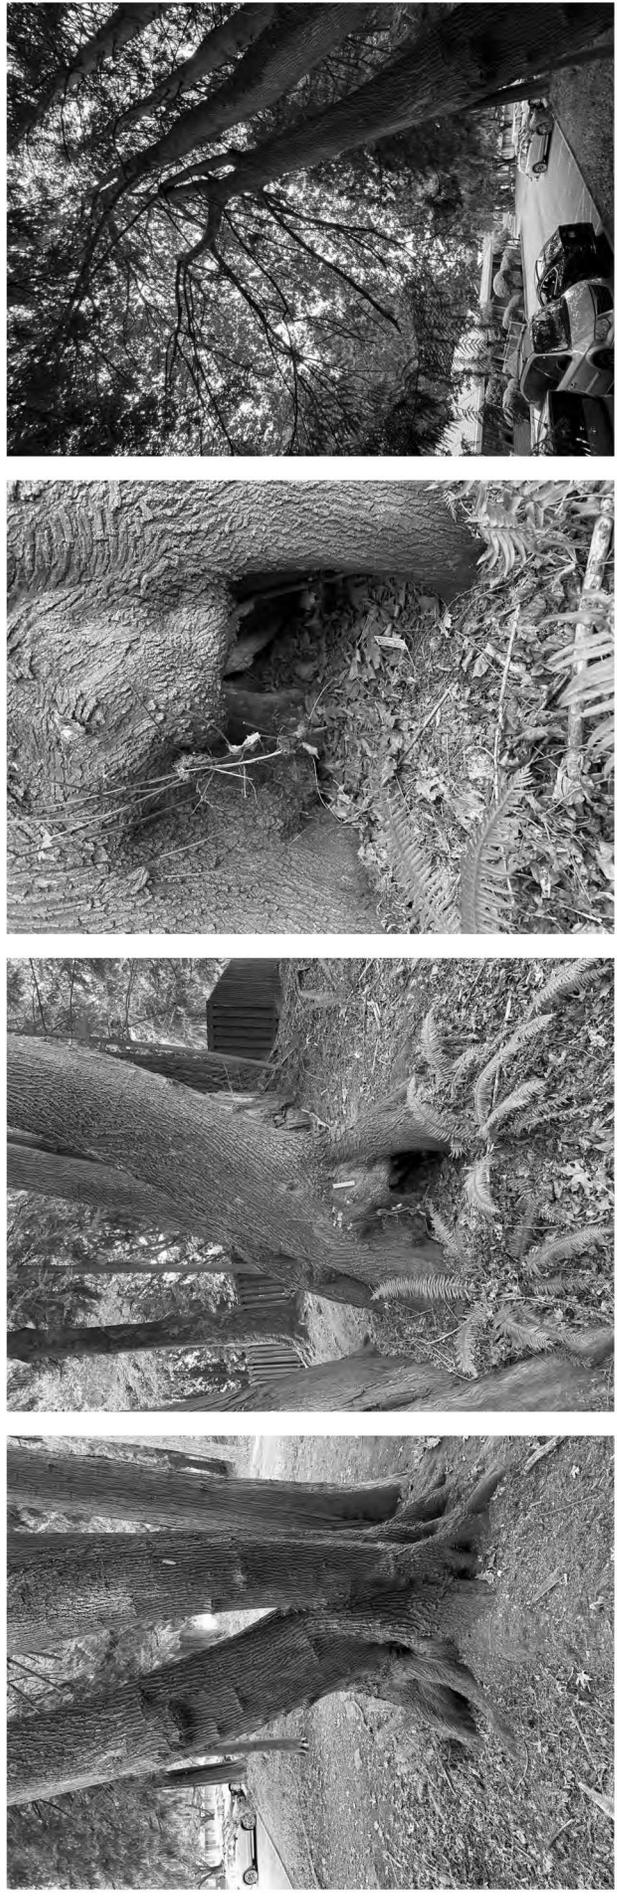
Tree ID: **45**

Notes: This tree is slightly suppressed by neighboring trees. Damage has occurred to buttress roots on the west side of the tree.

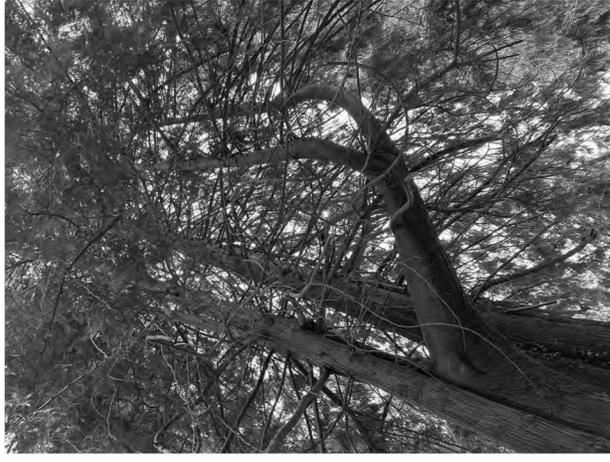
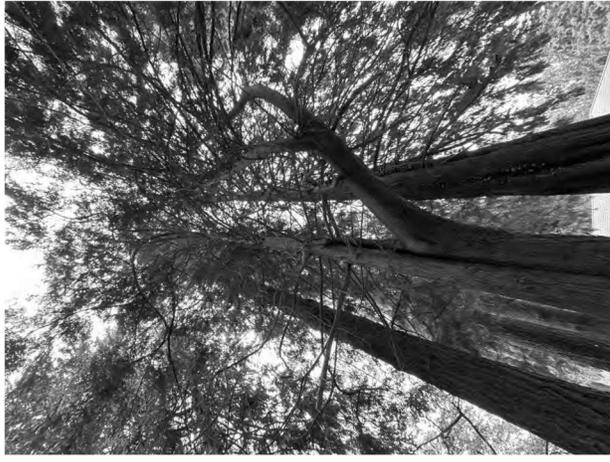
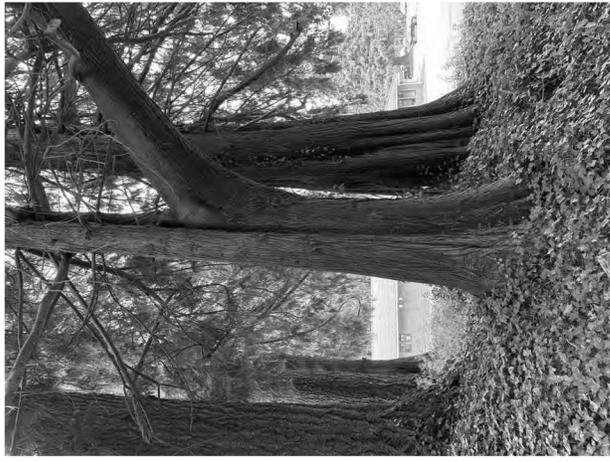
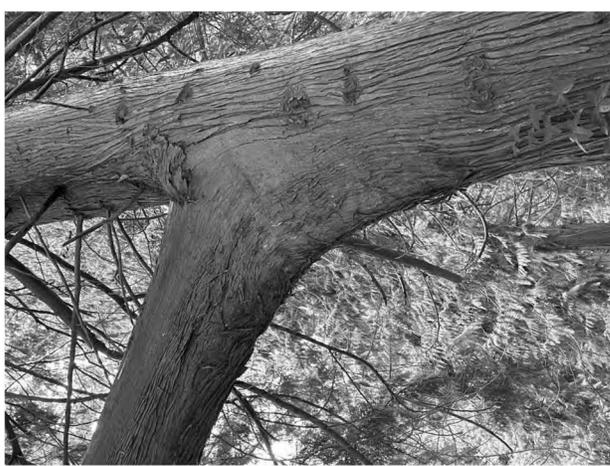
Notes: This tree appears to be two trees that have grown together and intertwined over the years. There is a very large lateral branch on the south side that contains two upright stems toward the end. There is significant reaction growth to support this branch at the main stem; the attachment seems very robust. English ivy is growing on the stem of this tree and throughout its root zone.

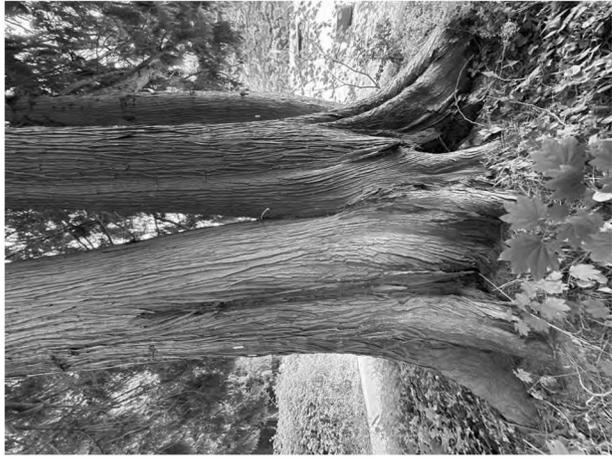
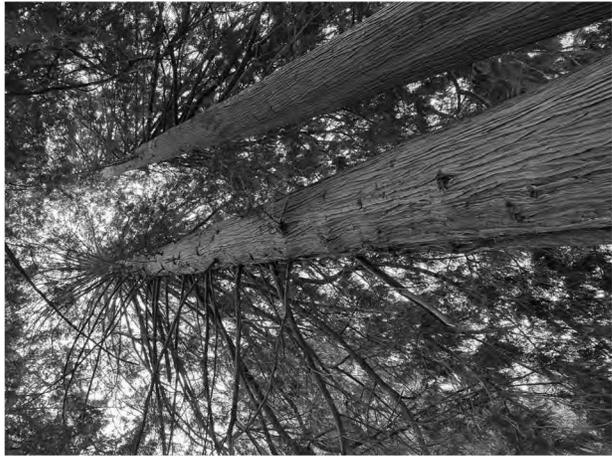
Notes: This tree has two codominant stems. This may be two trees that have grown together over time. The stems appear stable and strongly attached at their union. English ivy is growing on the stem of this tree and throughout its root zone.

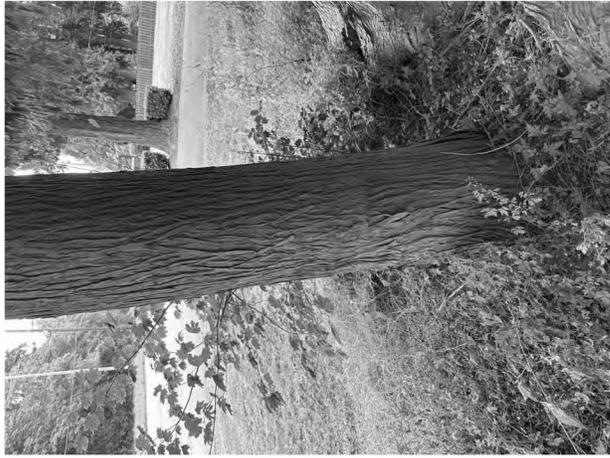
Tree ID: **78**

Notes: This tree has some longer larger branches on the south side, but they appear to be relatively stable and unlikely to contact targets.

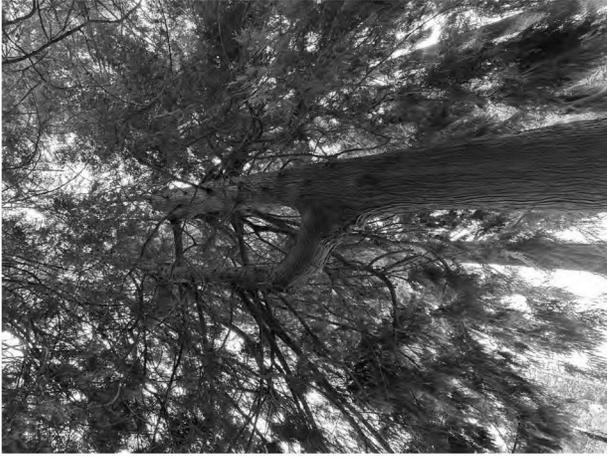
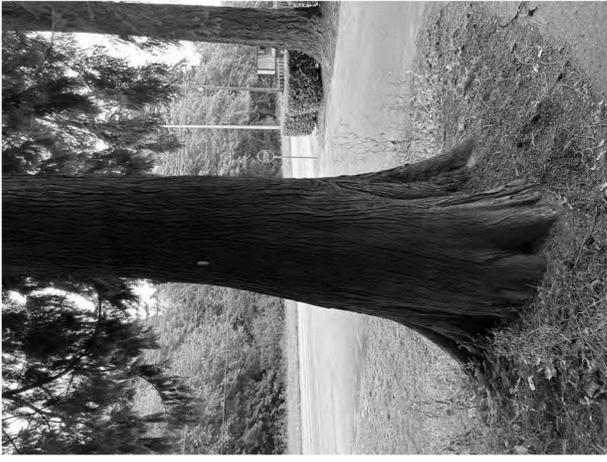
Tree ID: **79**

Notes: This tree lost its top at one point and has since compensated with advantageous growth from lateral branches. This reaction growth has resulted in characteristic candelabra branch formations seen typically with old-growth cedar trees. This growth appears to be stable at this time, though it should be monitored. An option to reduce these candelabra branches is offered to further lower the likelihood of failure if desired.
