United General District 304 Facility Tree Risk Assessment

ISA Level 2 Basic Tree Risk Assessment and Risk Mitigation Plan

September 16, 2024

**United General District 304 Facility
Sedro-Woolley, Washington**

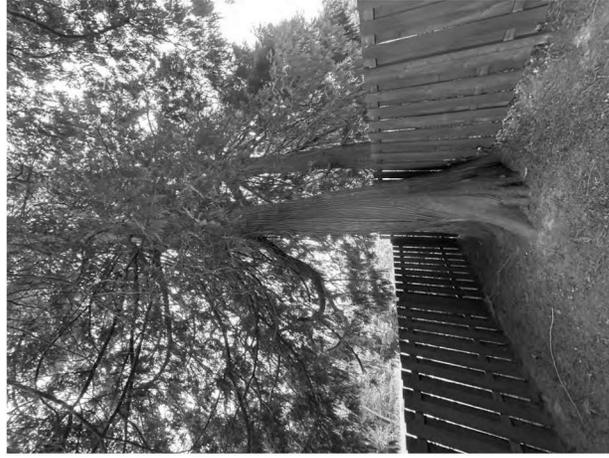
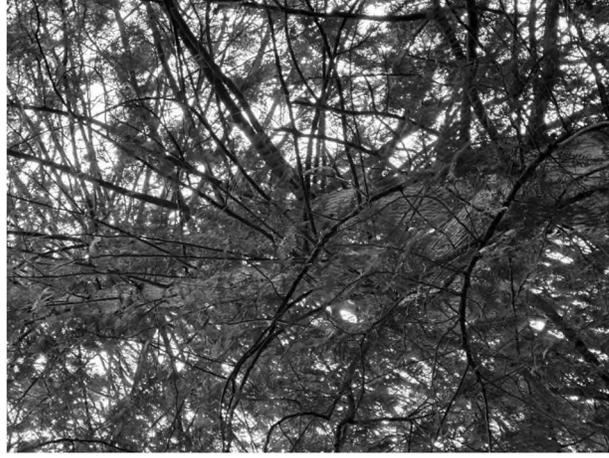
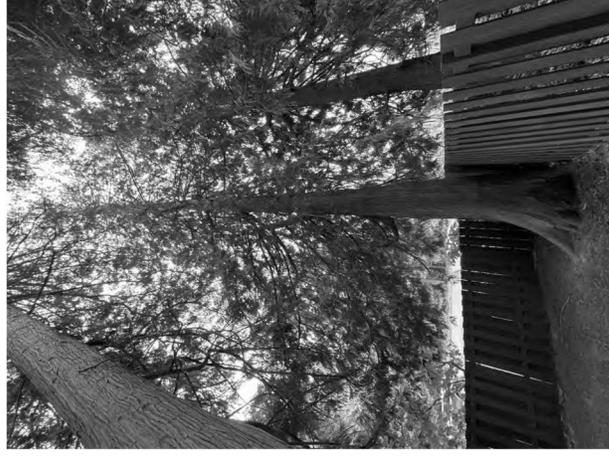
Tree ID: **2**

Notes: This tree has two slightly codominant tops in the upper canopy. The tops appear to be well attached and do not appear to contain included bark at their union; however, the union is difficult to see clearly from the ground.

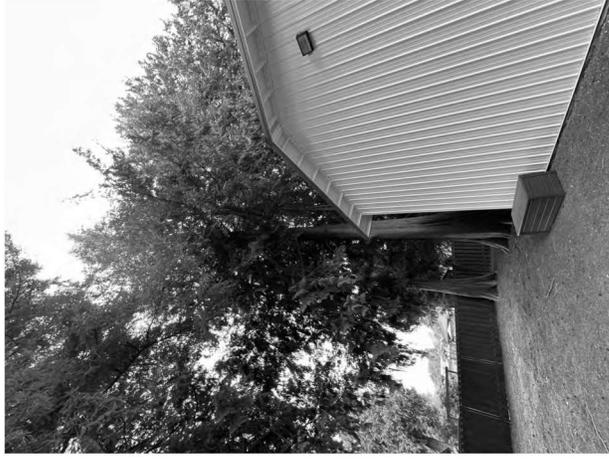
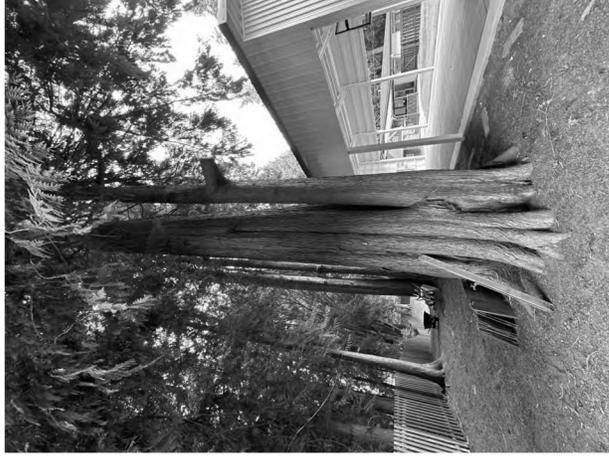
Tree ID: **14**

Health	Structure	Form
Fair	Poor	Poor

Recommendations: Remove the tree or convert it to a snag.

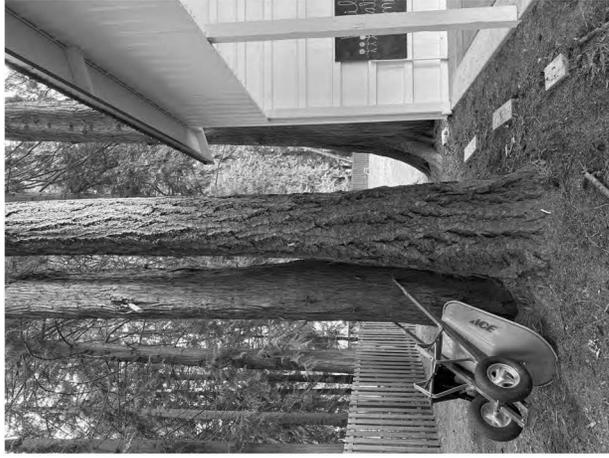
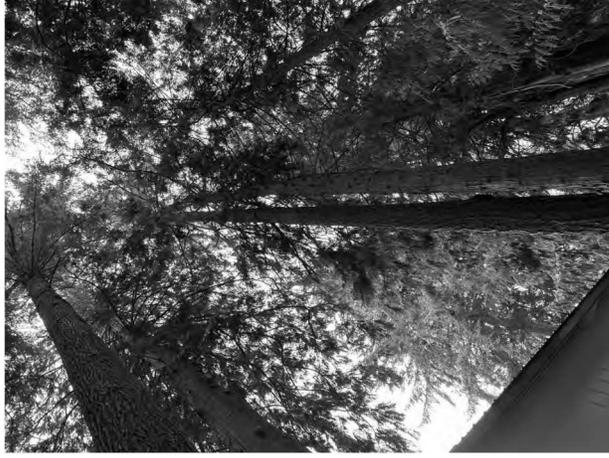
Tree ID: **18**

Health	Structure	Form
Good	Good	Fair

Recommendations: Monitor.

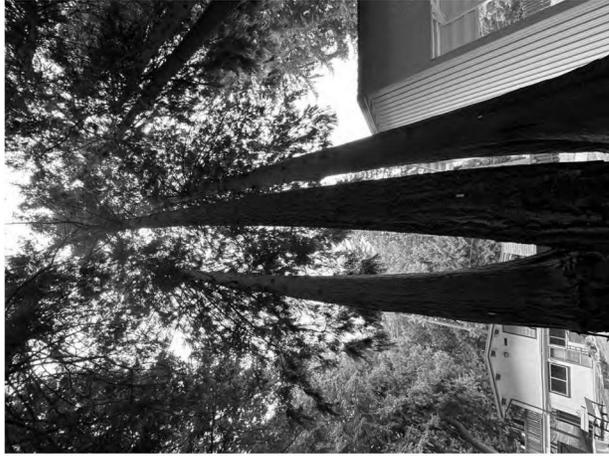
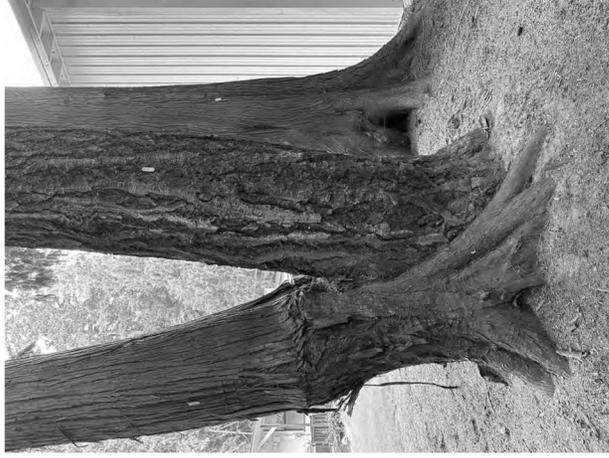
Tree ID:

Notes: This tree has grown into and has fused with the neighboring fir tree to the south. This tree leans significantly to the north. The tree has a significant defect at around 5 feet from grade. There appears to be a girdling material, like a wire, embedded within the trunk that has caused this significant defect. I have seen Cedar trees fail at these girdled points. Given the significant lean, this tree should be mitigated to prevent future conflicts.

Recommendations: Option 1: Remove the tree or convert it to a snag. Option 2: Retain and monitor through a more frequent, annual inspection interval.

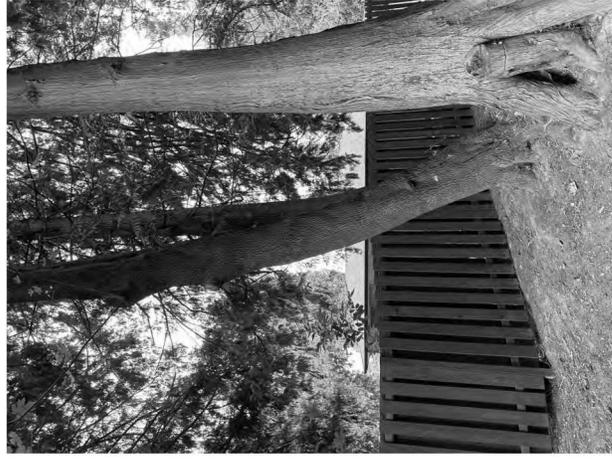
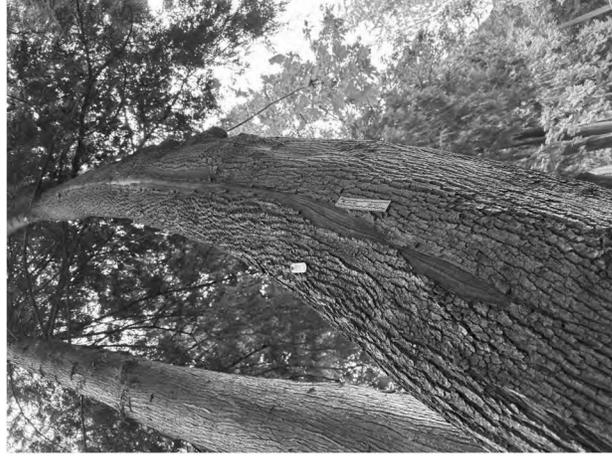
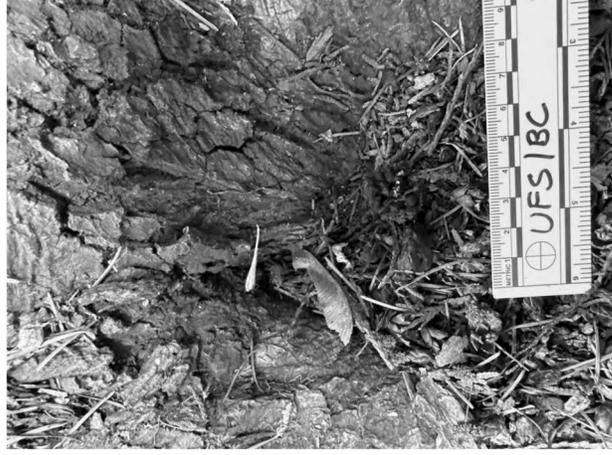
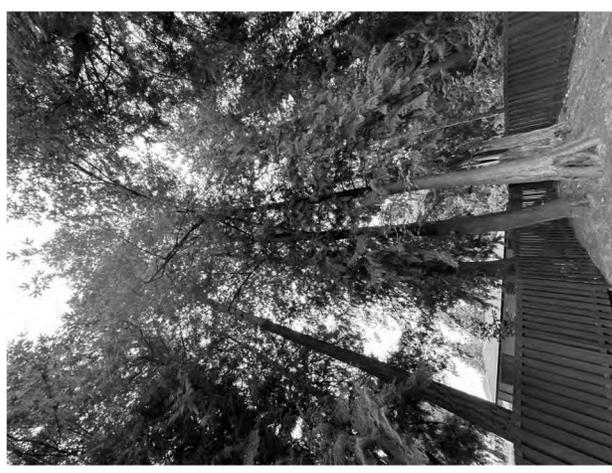
Tree ID: **21**

Notes: This tree leans significantly to the south. The tree has self-corrected over time. There appear to be numerous stress cracks on the stem from the significant lean. I observed what appeared to be brittle cinder fungus on the north side at the base. There is a large failed branch hanging in the upper canopy that could be prone to dislodging.

Recommendations: Option 1: Remove the tree or convert it to a snag. Option 2: Retain and monitor through a more frequent, annual inspection interval.

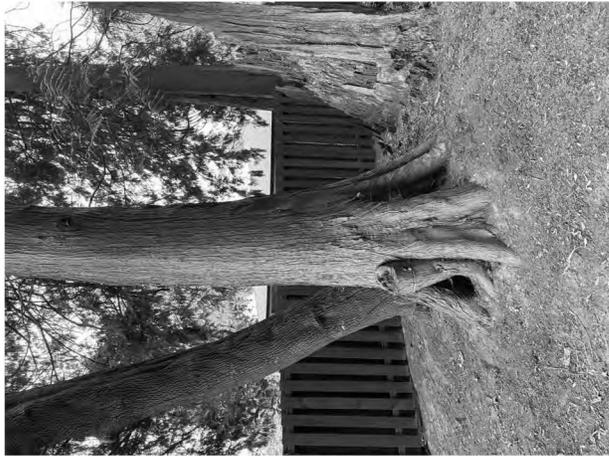
Tree ID: **23**

Notes: This is a very large cedar. It appears this tree may have grown from a nurse stump. This tree has a significant lean to the north. The tree has self-corrected significantly over time, creating a significant bow in the trunk. Most of the live branching is on the south side of the tree. The base of the tree contains various areas of decay and hollows. Significant reaction growth has occurred around these hollow areas at the base; it appears this tree has adapted to these defects over time.

Recommendations: Retain and monitor through a more frequent, annual inspection interval.

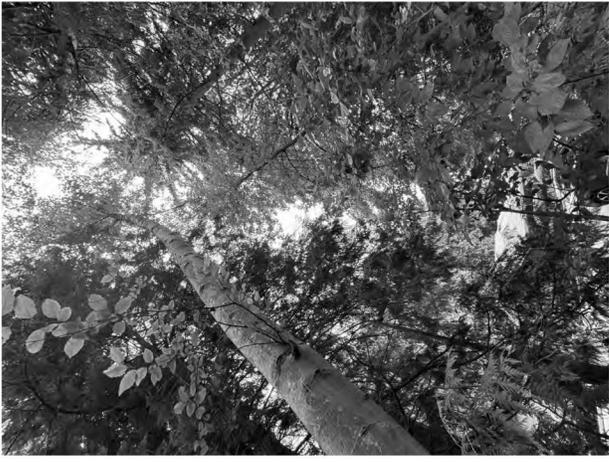
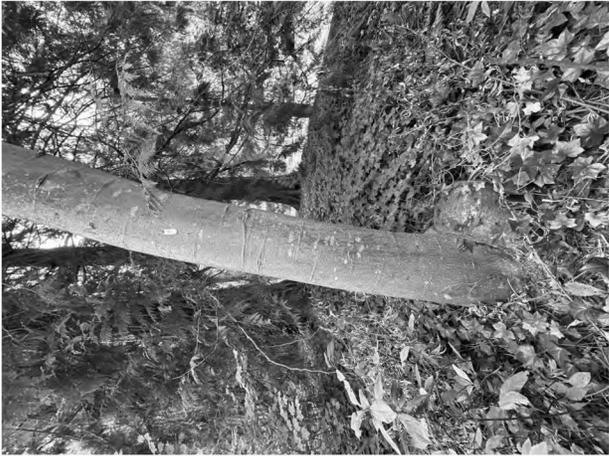
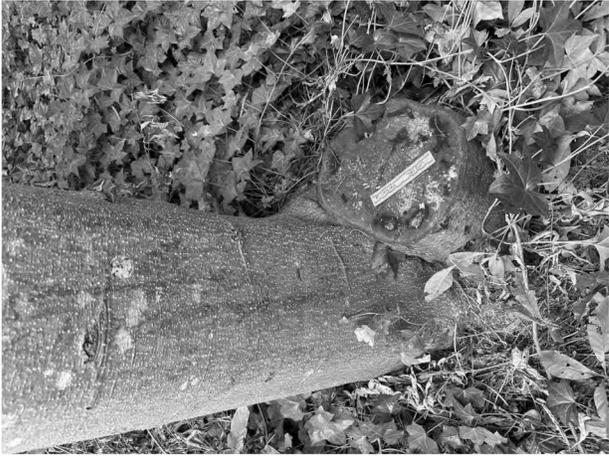
Tree ID: **25**

Notes: This tree leans significantly to the northeast. The primary fall direction would be into the parking spaces below. A neighboring stem that adjoins the lower trunk has been removed.

Recommendations: Remove the tree or convert it to a snag.

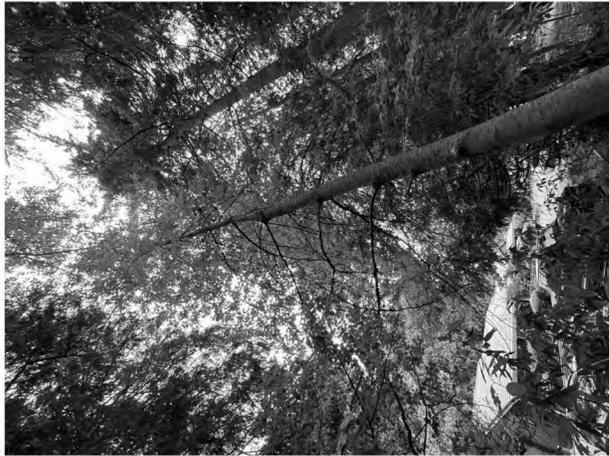
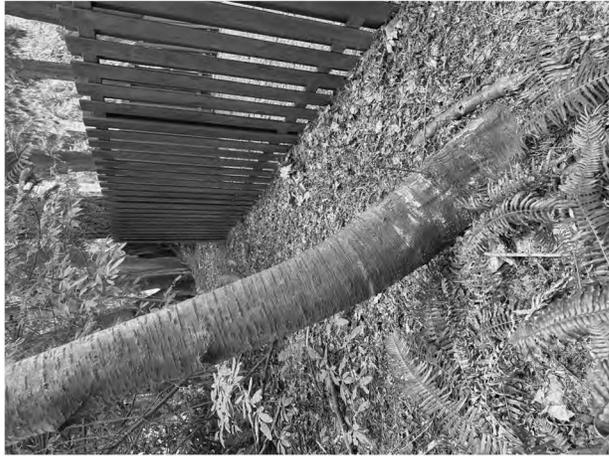
Tree ID: **26**

Notes: This tree leans significantly to the north. The tree is slightly suppressed, but appears to be stable.

Recommendations: Monitor.

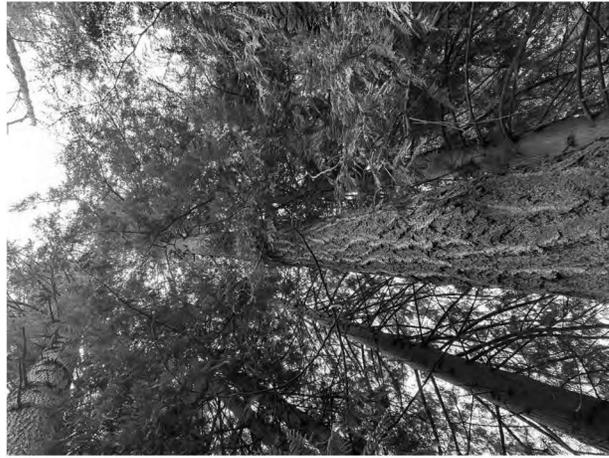
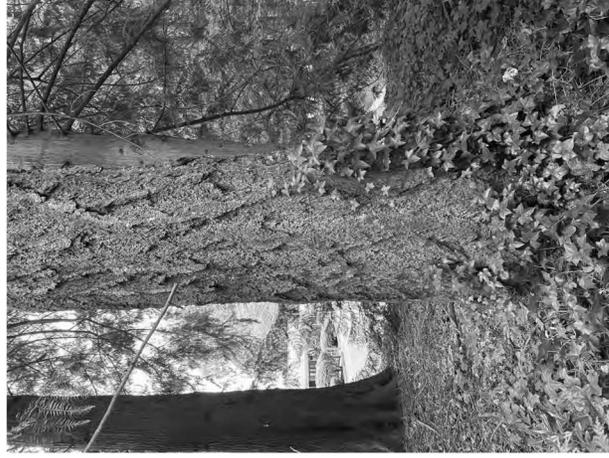
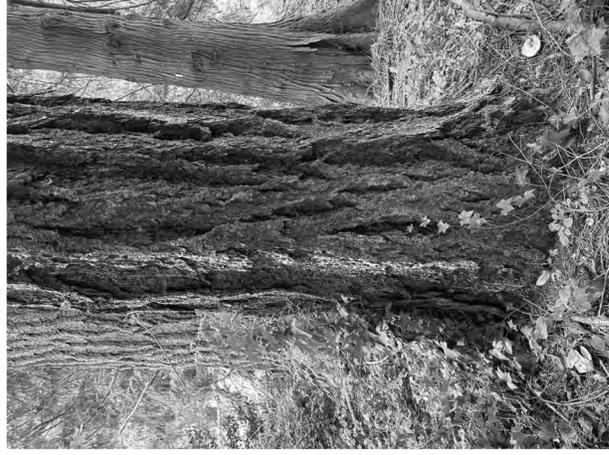
Tree ID: **28**

Notes: This tree exhibits slightly diminished vigor in the canopy and contains some dead branching in the lower canopy. English ivy is present throughout root zone.

Recommendations: Monitor.

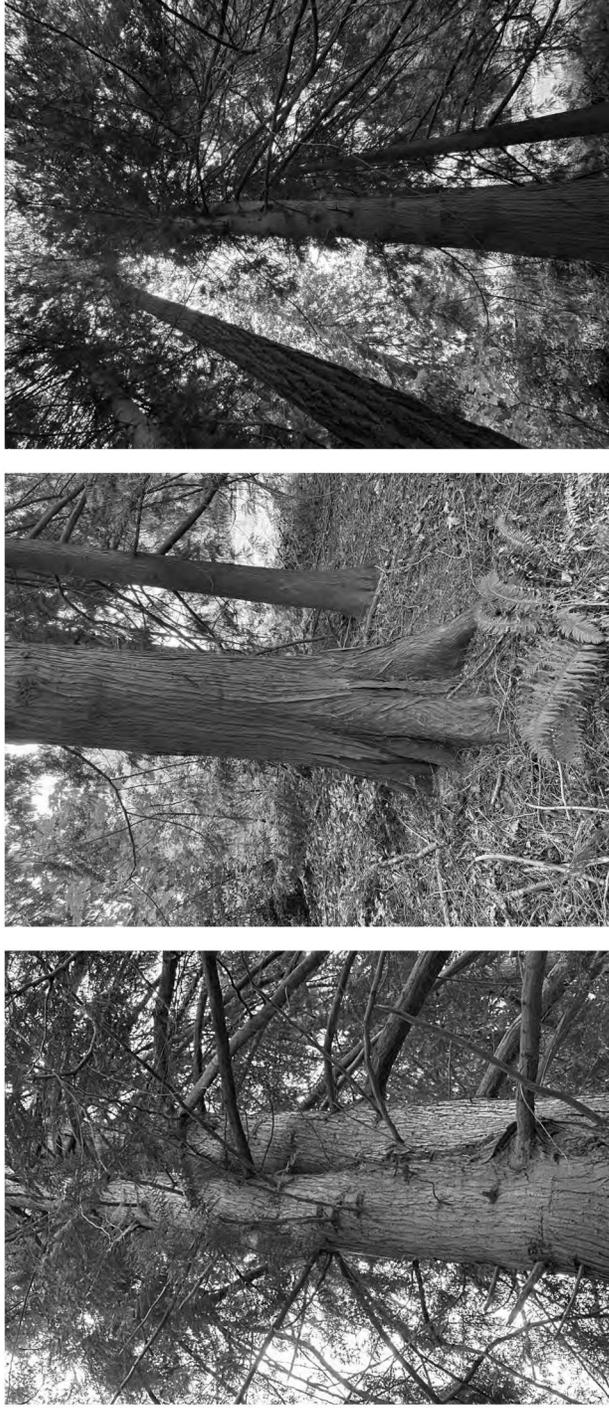
Tree ID: **30**

Notes: This tree has two codominant stems that emerge at around 12 feet. The codominant stems appear to contain included bark at the union; however, the stems appear to be significantly intertwined with branches, which lessens the likelihood of the stems failing.

Recommendations: Monitor.

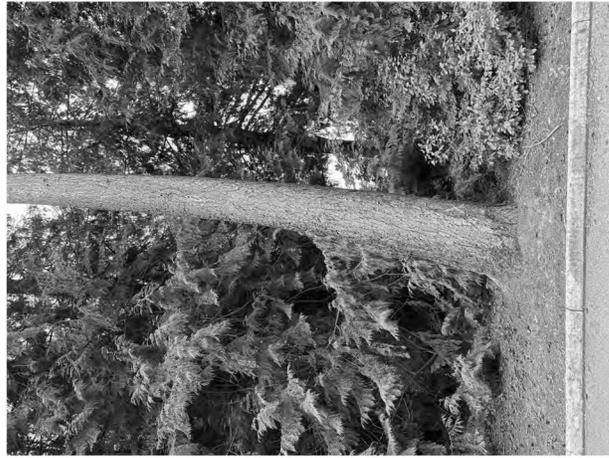
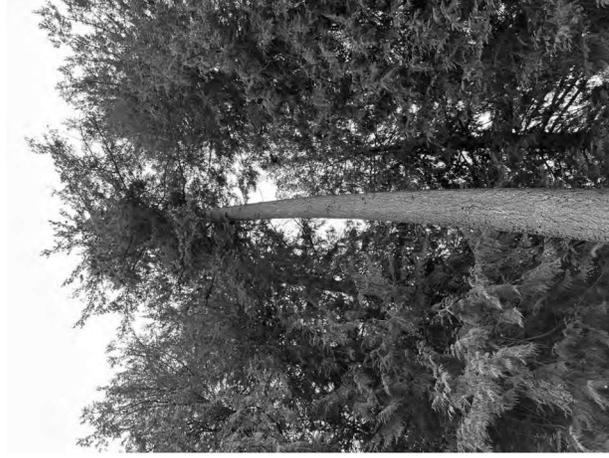
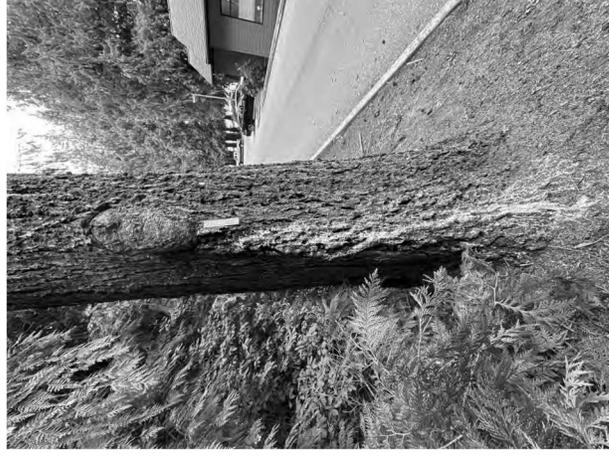
Tree ID: **33**

Notes: This tree exhibits slightly diminished vigor in the canopy. The tree leans slightly to the northwest and has a corrected lean. There is an old injury on the southeast side of the trunk at around 6 feet. Pitch is oozing from below the occluded injury.

Recommendations: Monitor.

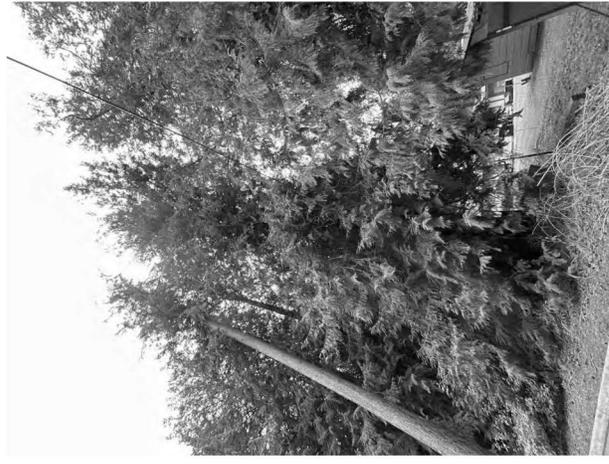
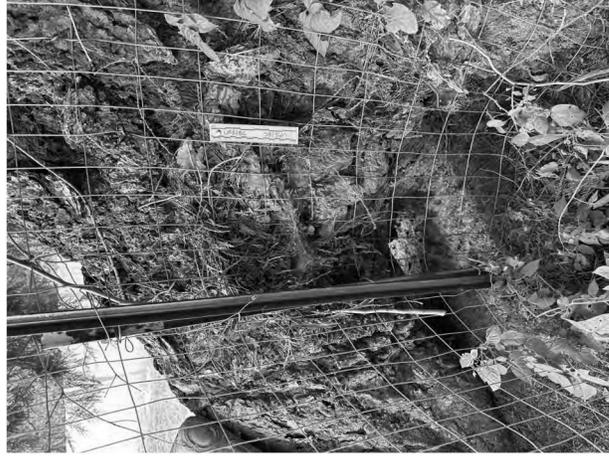
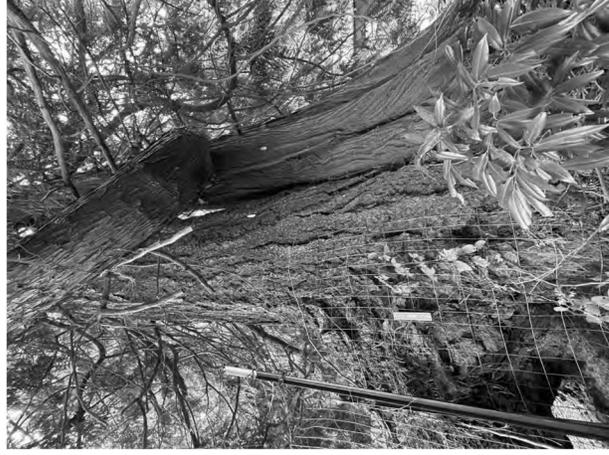
Notes: This is a very large tree with a stilted root on the west side. The tree appears to straddle the property line. This tree adjoins the neighboring cedar tree. Both trees are growing together and likely reliant on the other.

Recommendations: Monitor.

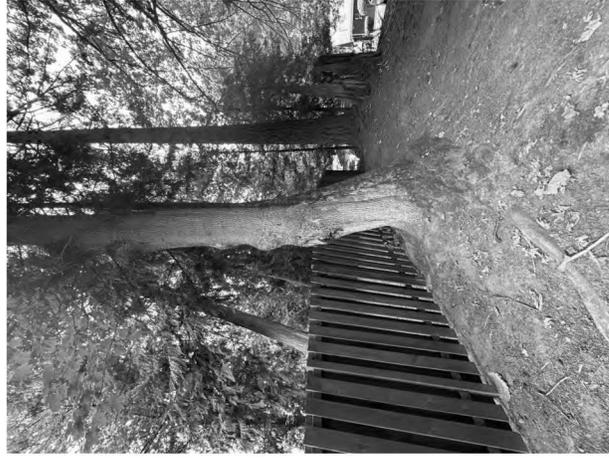
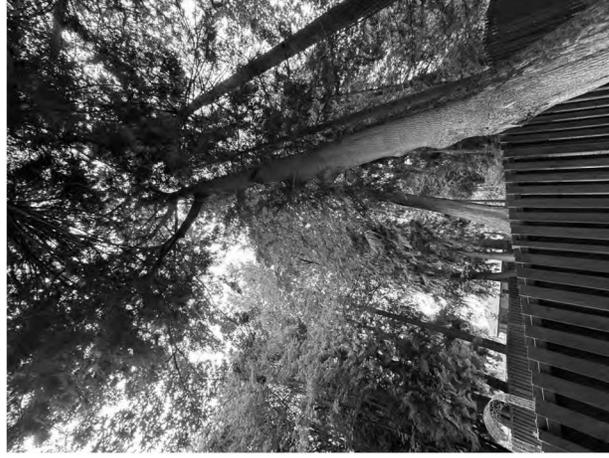
Notes: This tree has significant surface roots exposed at the soil surface. There are multiple large pruning cuts from large branches on the southmost side. There is some slight oozing of material coming from the lowest pruning injury. Minor deadwood is present in the upper canopy.

Recommendations: Monitor.

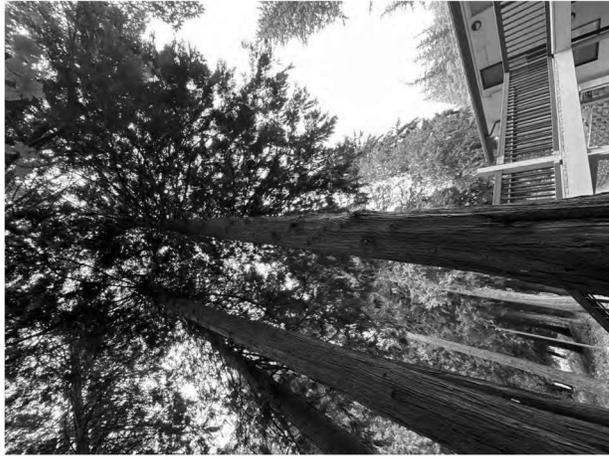
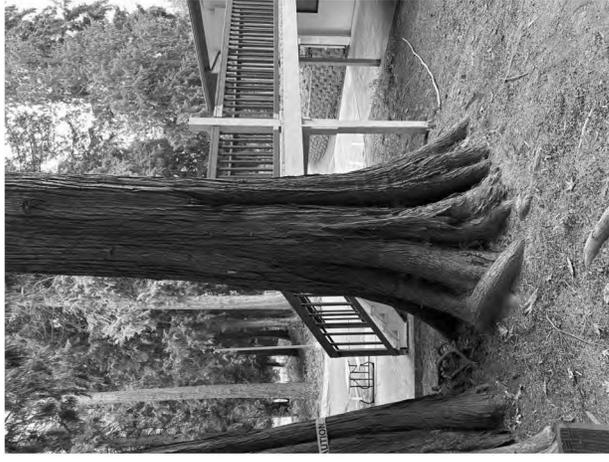
Tree ID: **39**

Condition Rating: Fair (73%)

Recommendations: Monitor.

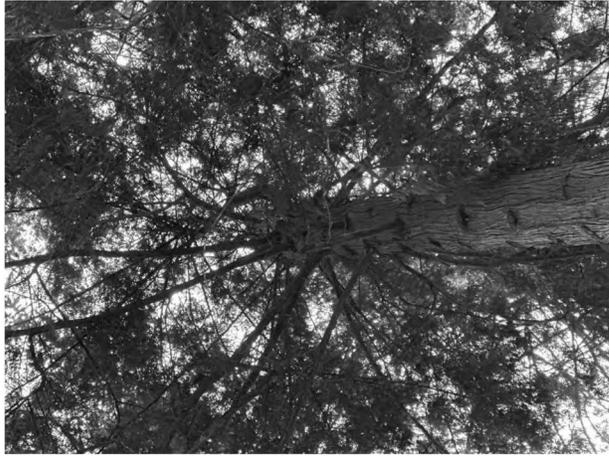
Tree ID: **42**

Notes: This large cedar exhibits slightly diminished vigor in the upper canopy. The lower portion of the stem, up to roughly 12 feet, bulges and appears to be swollen, which is likely indicative of internal decay or adaptive stress from wind loading. The tree leans slightly to the east and bows upwards in a self-corrective manner.

Recommendations: Monitor.

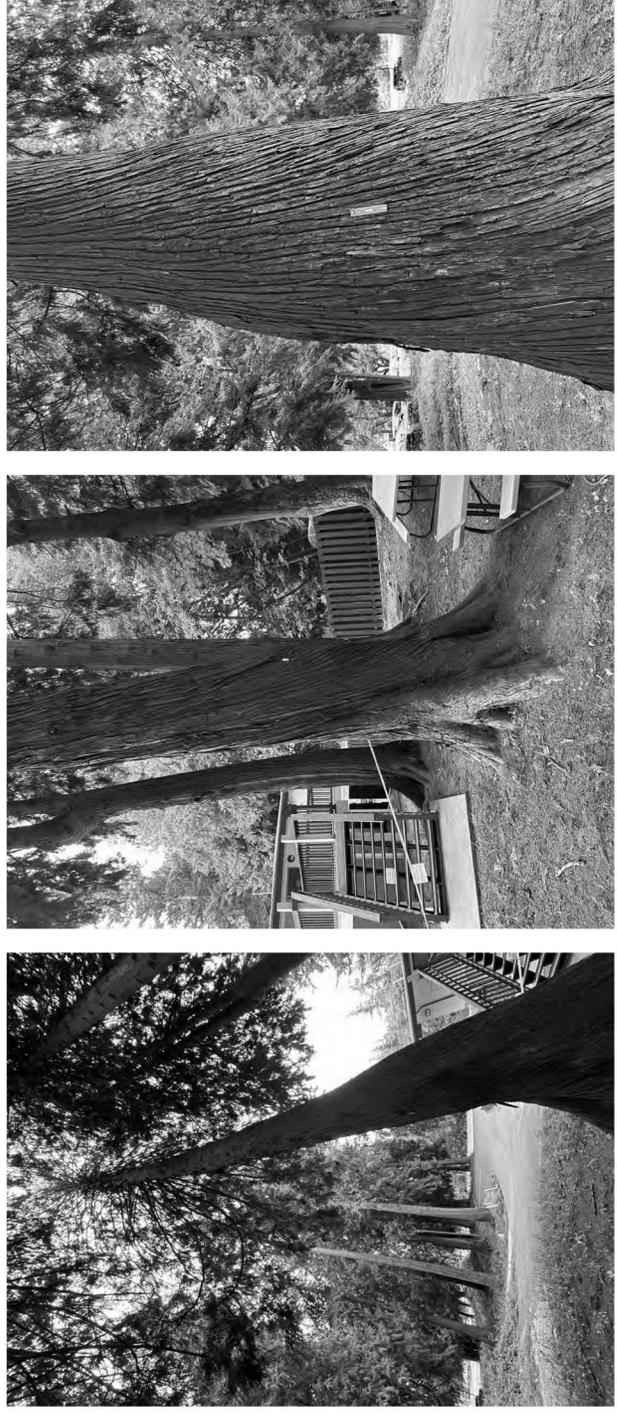
Tree ID: **43**

Condition Rating: Fair (60%)

Recommendations: Monitor.

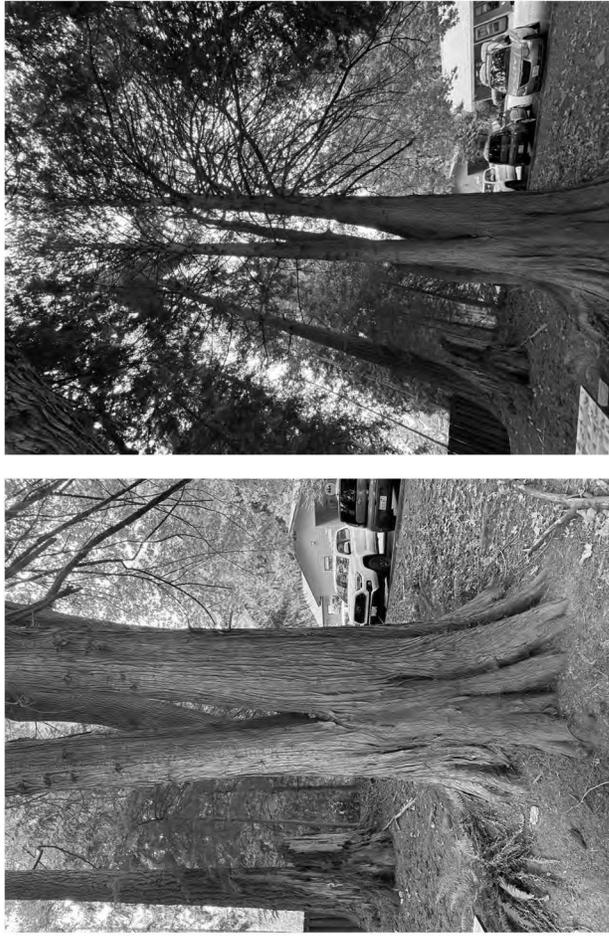
Tree ID: **44**

Likelihood of Failure	Likelihood of Impact	Consequences
Possible	High	Severe

Recommendations: Retain and monitor through a more frequent, annual inspection interval.

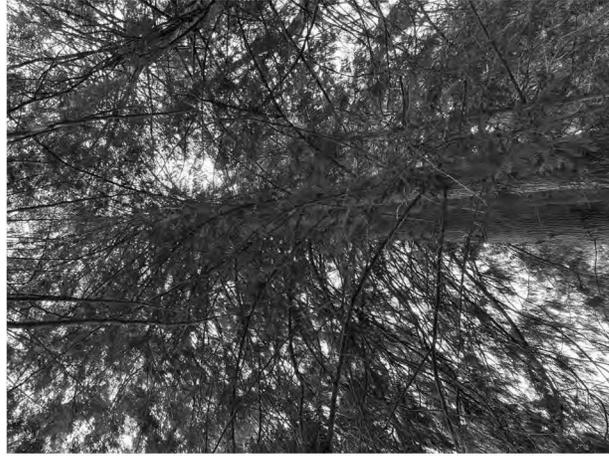
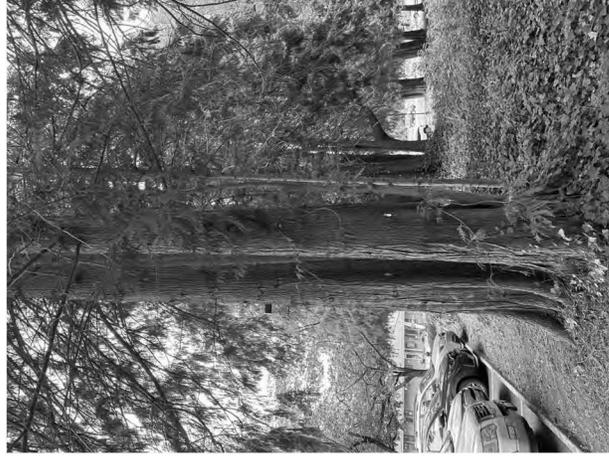
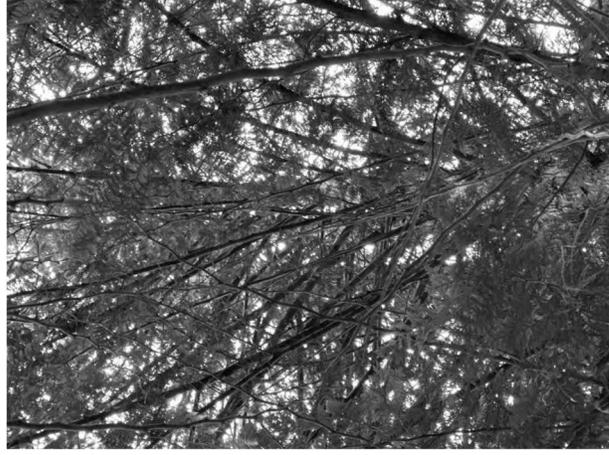
Tree ID: **49**

Notes: English ivy is growing on the stem of this tree and throughout its root zone.

Recommendations: Monitor.

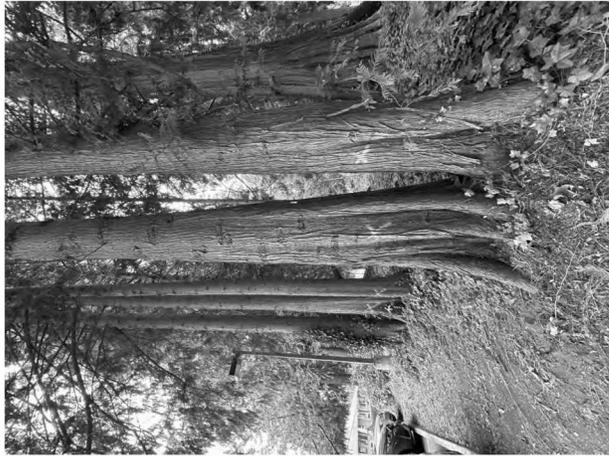
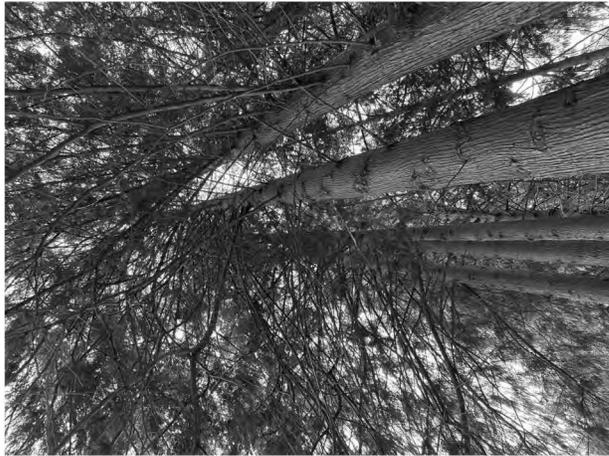
Tree ID: **50**

Notes: English ivy is growing on the stem of this tree and throughout its root zone.

Recommendations: Monitor.

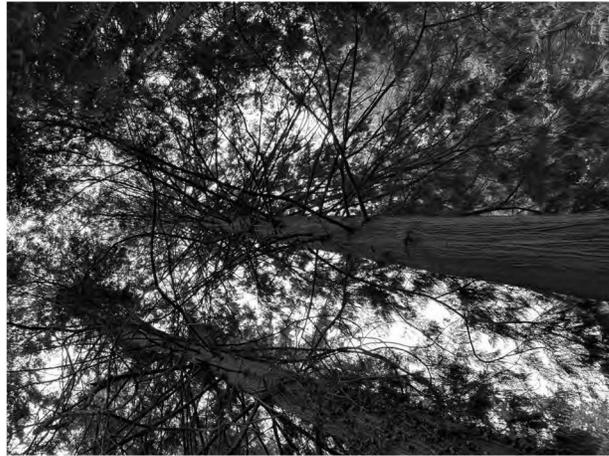
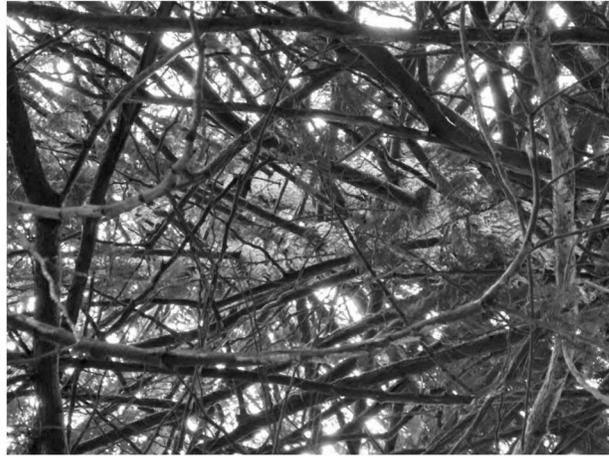
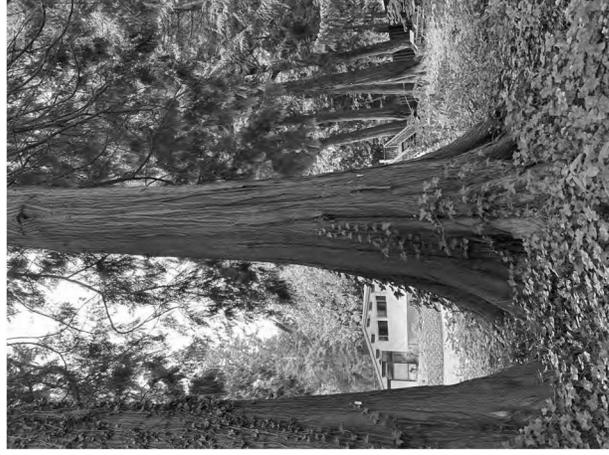
Notes: This large cedar has multiple codominant stems in the very upper portion of the canopy. It is hard to tell what the condition of the unions is. English ivy is growing on the stem of this tree and throughout its root zone.

Recommendations: Option 1: Monitor. Option 2: Conduct a Level 3 Advanced Assessment - aerial inspection of codominant union.

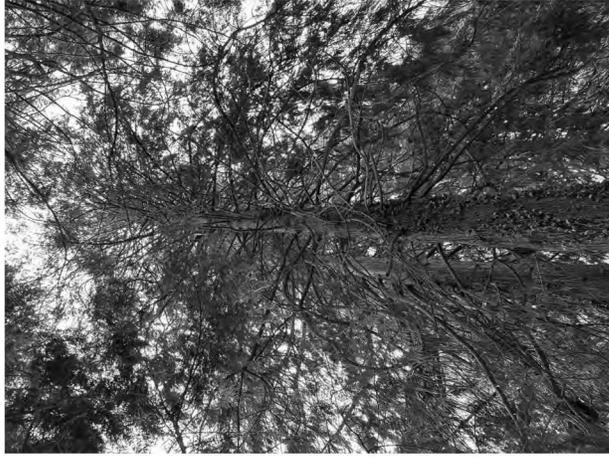
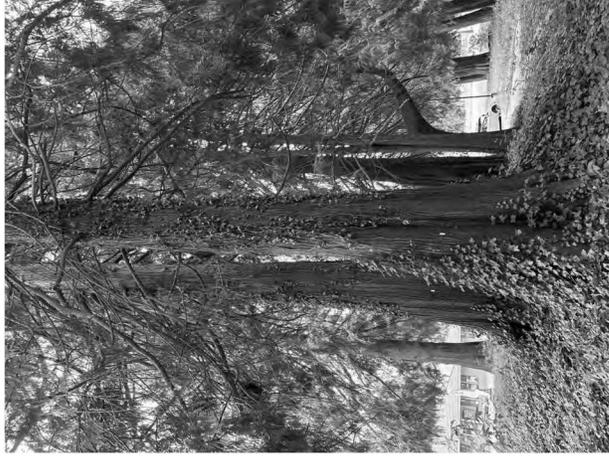
Tree ID: **55**

Notes: This tree exhibits a history of branch failure on north side. English ivy is growing on the stem of this tree and throughout its root zone.

Recommendations: Monitor.

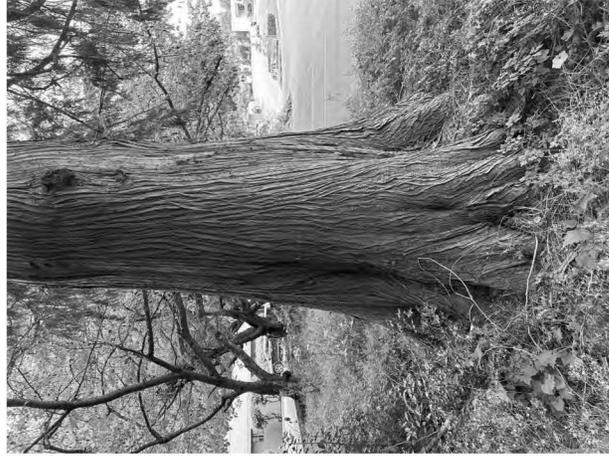
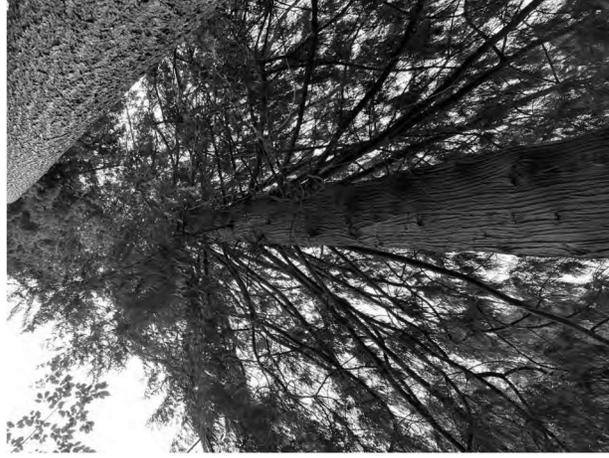
Tree ID: **61**

Notes: This tree contains some very long branches on the east side that may be prone to failing during abnormal weather events. English ivy is growing on the stem of this tree and throughout its root zone.

Recommendations: Monitor.

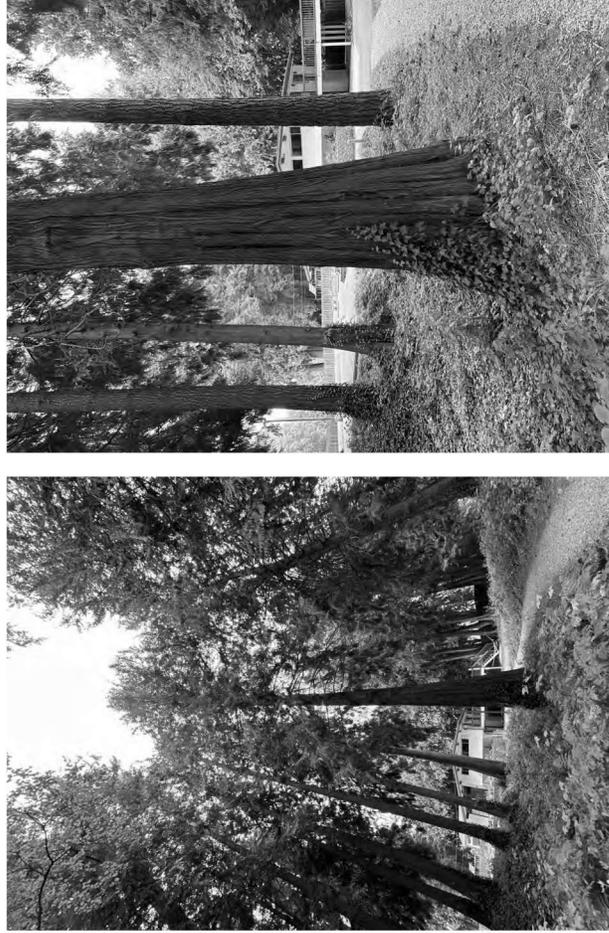
Tree ID:

Likelihood of Failure	Likelihood of Impact	Consequences
Possible	Medium	Severe

Notes: This tree has been limbed up in the past. There are some very long branches on the north side of the tree that may be prone to failing during abnormal weather events. The trunk exhibits a kink-like defect at about 80 feet that may be from an old topping cut. The defect appears stable at this time; however, I have observed similar defects fail during high winds.

Recommendations: Option 1: Monitor. Option 2: Conduct a Level 3 Advanced Assessment - aerial inspection of the kink-like defect.

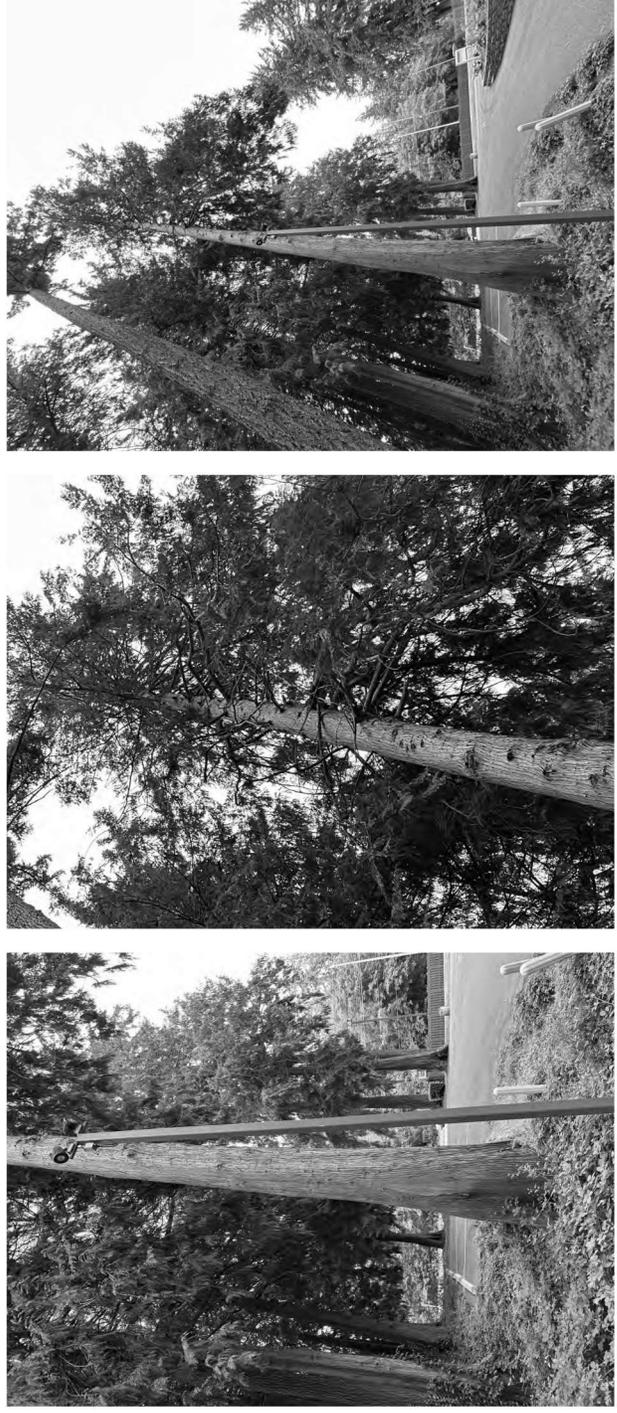
Tree ID: **65**

Likelihood of Failure	Likelihood of Impact	Consequences
Possible	Medium	Severe

Notes: There are some large longer branches on the west side of this tree that may be prone to failing during abnormal weather events.

Recommendations: Option 1: Monitor. Option 2: Reduce the length of the longest lower branches on the west side of this tree to lower the likelihood of failure and impact to targets below. Use proper reduction pruning cuts - 10 -15% reduction - pruning back to viable lateral branches.

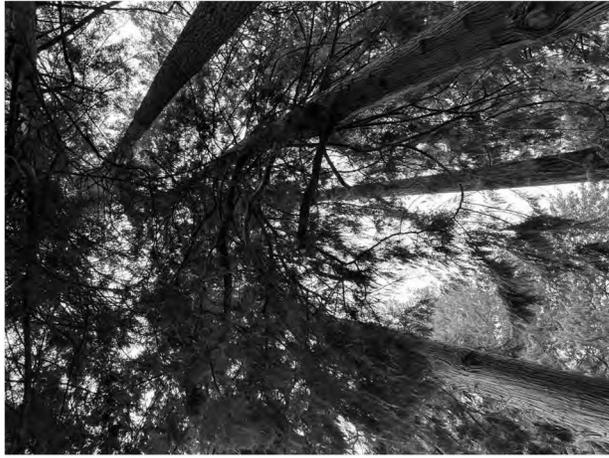
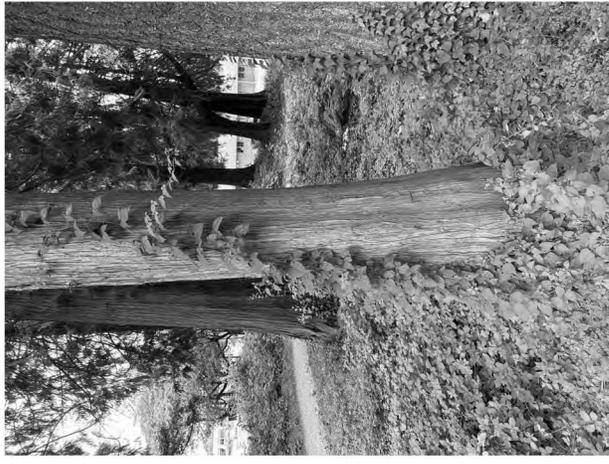
Tree ID: **66**

Likelihood of Failure	Likelihood of Impact	Consequences
Possible	Medium	Severe

Notes: There are some large longer branches on the west side of this tree that may be prone to failing during abnormal weather events.

Recommendations: Option 1: Monitor. Option 2: Reduce the length of the longest lower branches on the west side of this tree to lower the likelihood of failure and impact to targets below. Use proper reduction pruning cuts - 10 -15% reduction - pruning back to viable lateral branches.

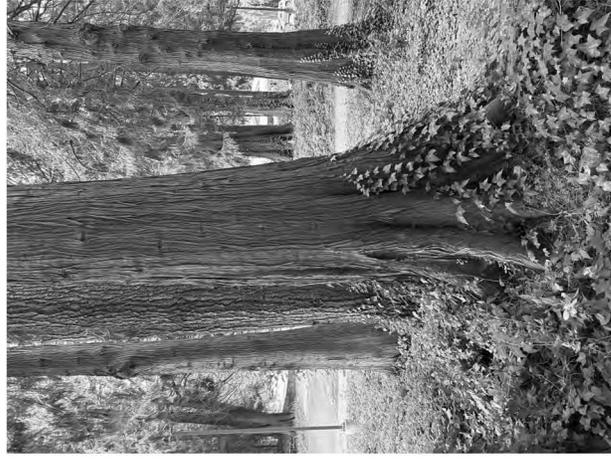
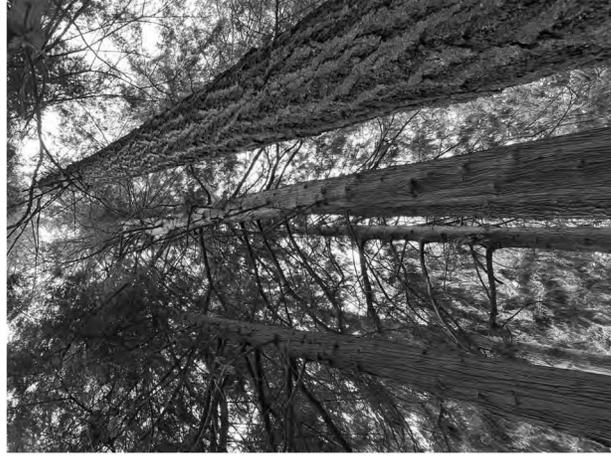
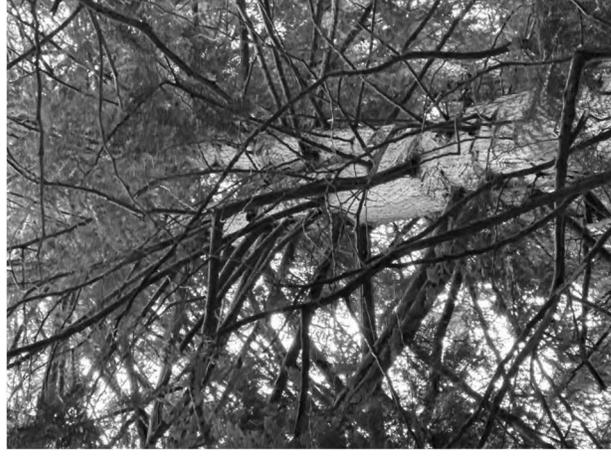
Tree ID: **68**

Likelihood of Failure	Likelihood of Impact	Consequences
Possible	Medium	Severe

Notes: This large cedar has two codominant stems in the upper portion of the canopy. It is hard to tell what the condition of the unions is. English ivy is growing on the stem of this tree and throughout its root zone.

Recommendations: Option 1: Monitor. Option 2: Conduct a Level 3 Advanced Assessment - aerial inspection of codominant union.

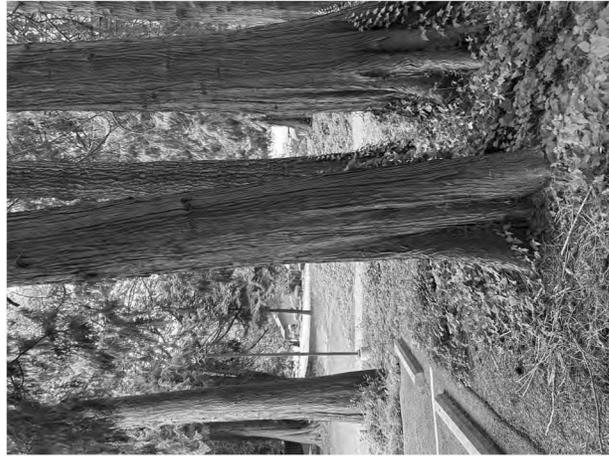
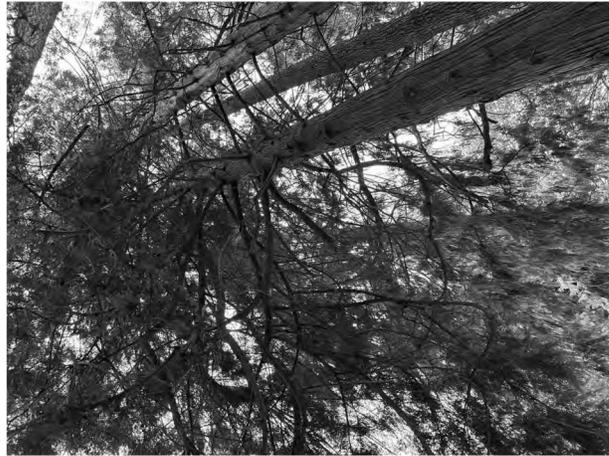
Tree ID: **69**

Likelihood of Failure	Likelihood of Impact	Consequences
Possible	Medium	Severe

Notes: There are some large longer branches on the west side of this tree that may be prone to failing during abnormal weather events.

Recommendations: Option 1: Monitor. Option 2: Reduce the length of the longest lower branches on the west side of this tree to lower the likelihood of failure and impact to targets below. Use proper reduction pruning cuts - 10 -15% reduction - pruning back to viable lateral branches.

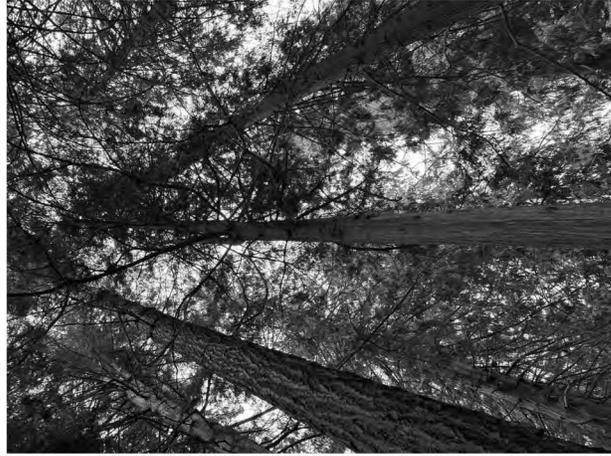
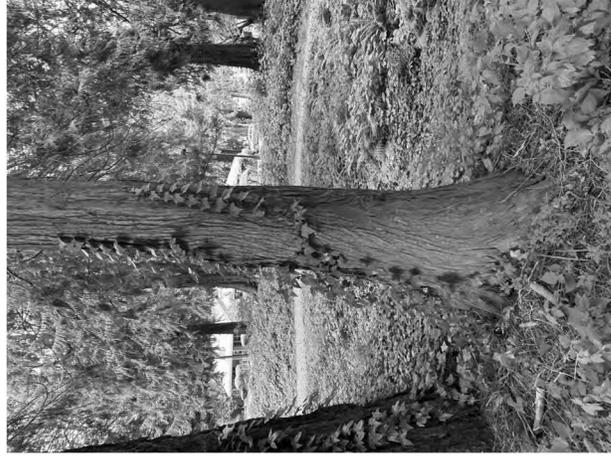
Tree ID: **71**

Likelihood of Failure	Likelihood of Impact	Consequences
Probable	Low	Severe

Notes: Sounding indicates significant hollows throughout the lower stem. Similar trees with extensive decay of this nature can be prone to contorting and folding in on themselves during storm and wind events. The tree is relatively well protected by surrounding trees but is still vulnerable to failure. Targets are not necessarily within striking distance.

Recommendations: Option 1: Monitor. Option 2: Remove the tree or convert it to a snag.

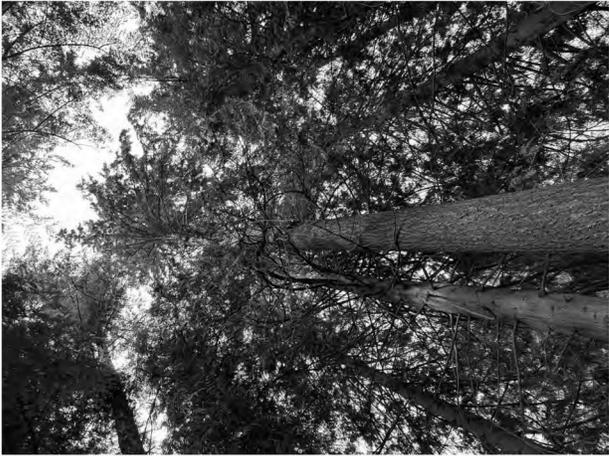
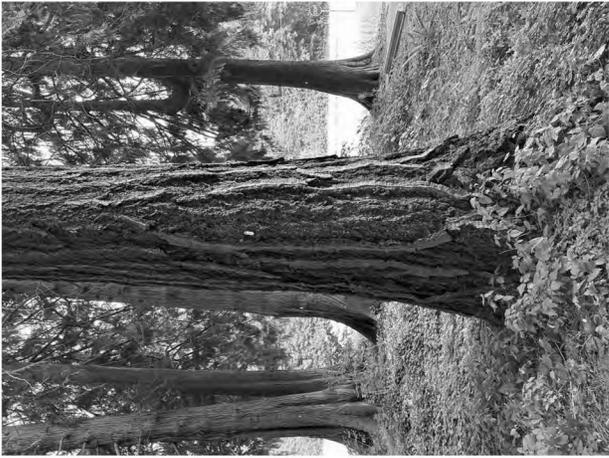
Tree ID: **75**

Likelihood of Failure	Likelihood of Impact	Consequences
Possible	Medium	Severe

Notes: This tree exhibits slightly diminished vigor in the canopy. Some dead branches are present in the lower canopy. A previous failed western hemlock was growing within 10 feet of this tree to the west.

Recommendations: Monitor.

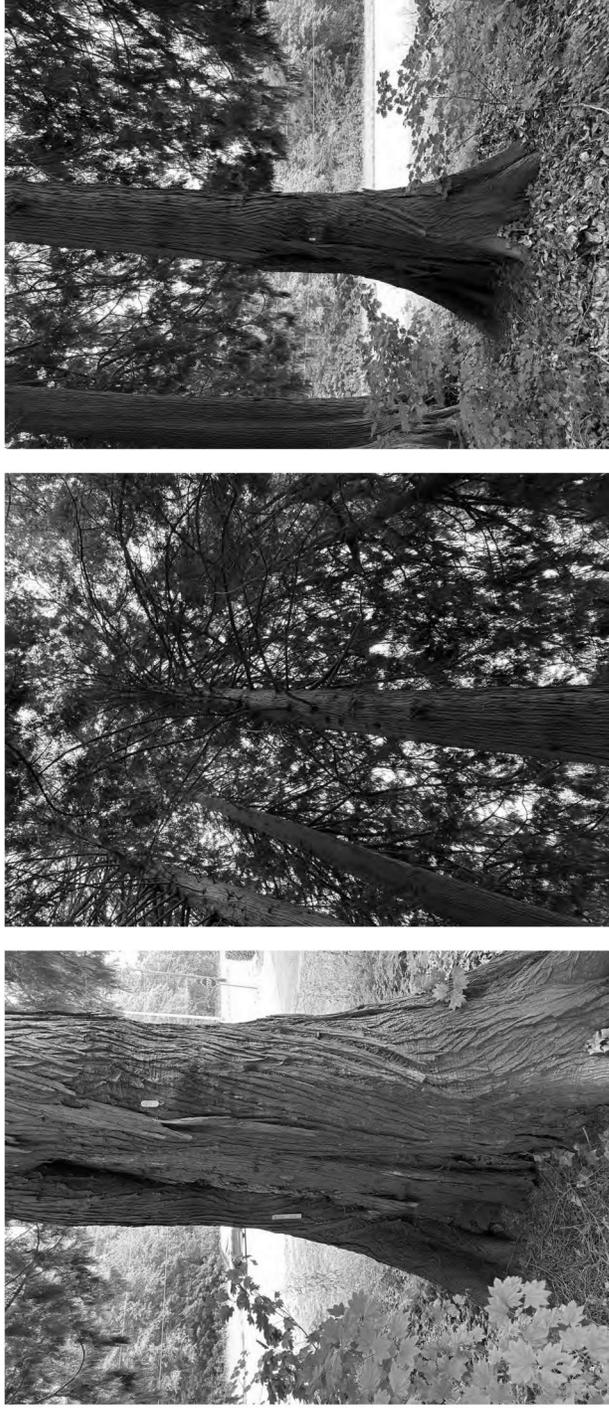
Tree ID: **76**

Likelihood of Failure	Likelihood of Impact	Consequences
Probable	High	Severe

Notes: This large cedar leans slightly to the west. The base of this tree contains advanced decay and an open cavity. The cavity is approximately 8 feet tall and around 3 feet wide. Sounding indicates hollows and decay. English ivy is growing on the stem of this tree and throughout its root zone.

Recommendations: Option 1: Remove the tree or convert it to a snag. Option 2: Significantly reduce the height of the tree and retain it as a living snag.
