United General District 304 Facility Tree Risk Assessment

ISA Level 2 Basic Tree Risk Assessment and Risk Mitigation Plan

September 16, 2024

**United General District 304 Facility
Sedro-Woolley, Washington**

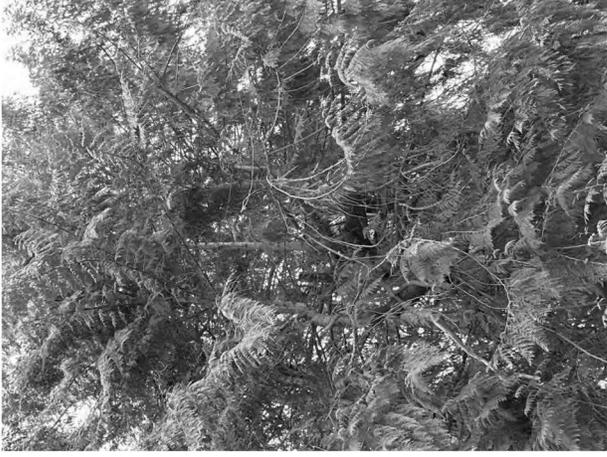
Tree ID: **79**

Likelihood of Failure	Likelihood of Impact	Consequences
Possible	High	Severe

Notes: This tree lost its top at one point and has since compensated with advantageous growth from lateral branches. This reaction growth has resulted in characteristic candelabra branch formations seen typically with old-growth cedar trees. This growth appears to be stable at this time, though it should be monitored. An option to reduce these candelabra branches is offered to further lower the likelihood of failure if desired.

Recommendations: Option 1: Monitor. Option 2: Reduce the height of candelabra branches; use proper reduction pruning cuts - 10 -15% reduction - pruning back to viable lateral branches.

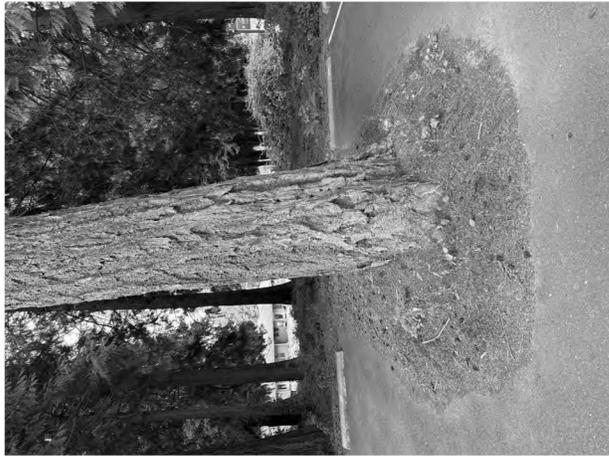
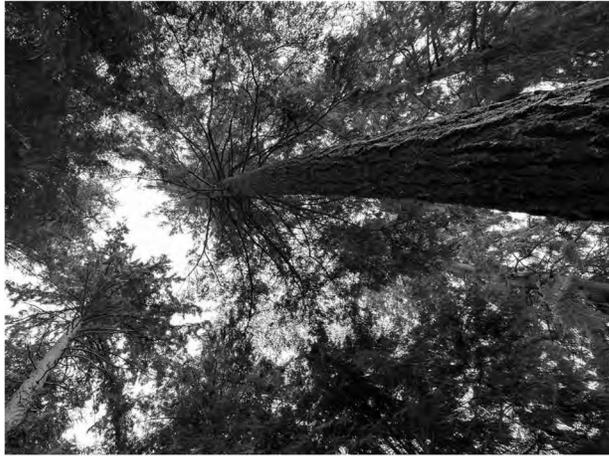
Tree ID: **80**

Likelihood of Failure	Likelihood of Impact	Consequences
Possible	Medium	Severe

Notes: Dead branched are present within the lower canopy of this tree. A previous failed hemlock was growing within 10 feet of this tree to the east.

Recommendations: Monitor.

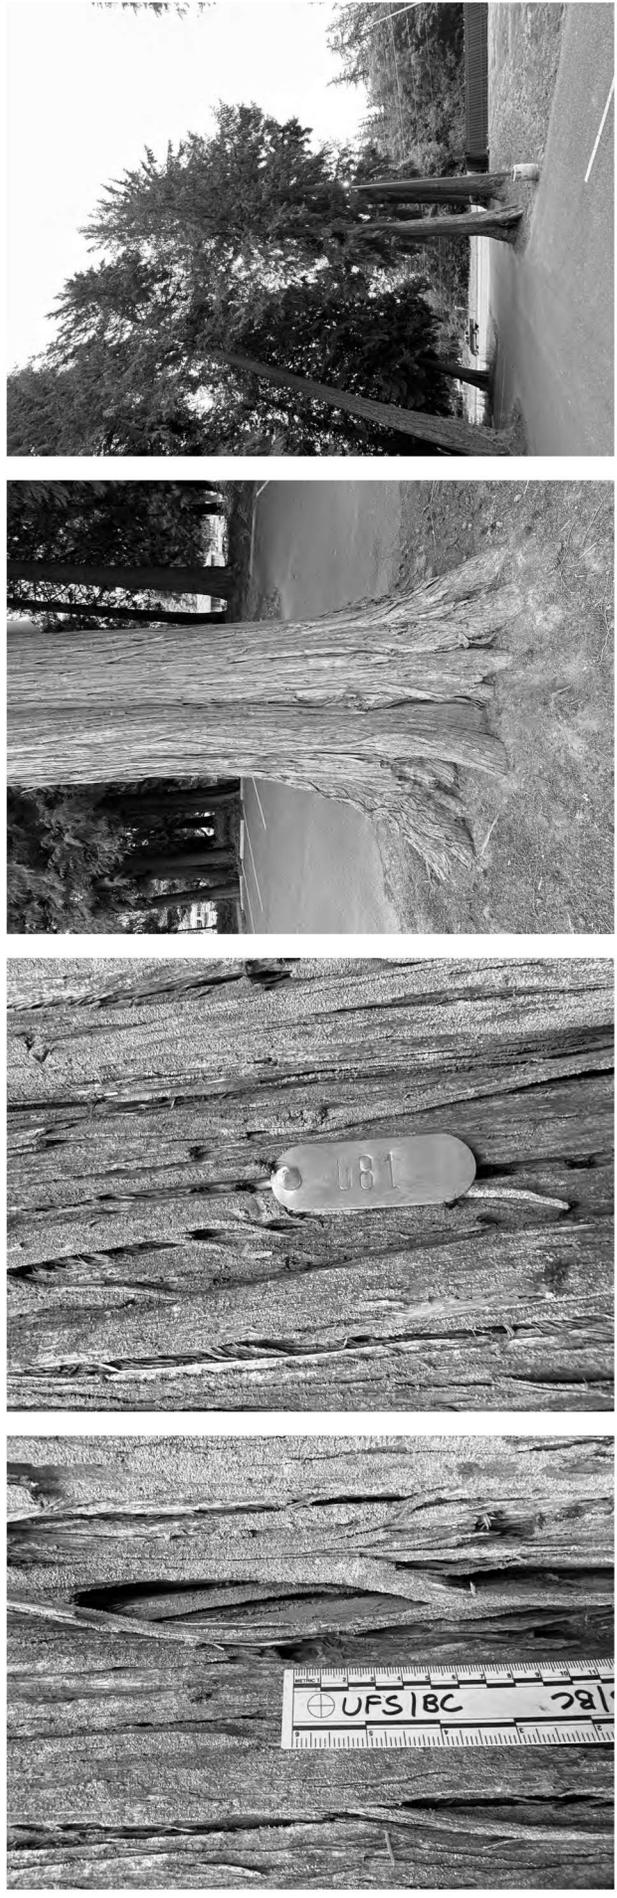
Tree ID: **81**

Likelihood of Failure	Likelihood of Impact	Consequences
Possible	Medium	Severe

Notes: The lower portion of this tree's stem appears to be weathered and inconsistent in its shape. There are locations where there are voids and hollows at the base and deep fluting. Significant ant activity was also observed, especially on the west portion of the trunk. There may be significant ant activity which could be compromising the internal wood structure, though sounding indicates mostly solid wood.

Recommendations: Option 1: Monitor. Option 2: Conduct a Level 3 Advanced Assessment - Tomography and diagnostics to evaluate ant colony extent if present.
